City of Lincoln Park
Community Planning & Development
1355 Southfield Rd.
Lincoln Park MI 48148
Phone: (313) 386-3100 ext. 30

**CDBG RENOVATION – 536 Farnham
SCOPE OF WORK**

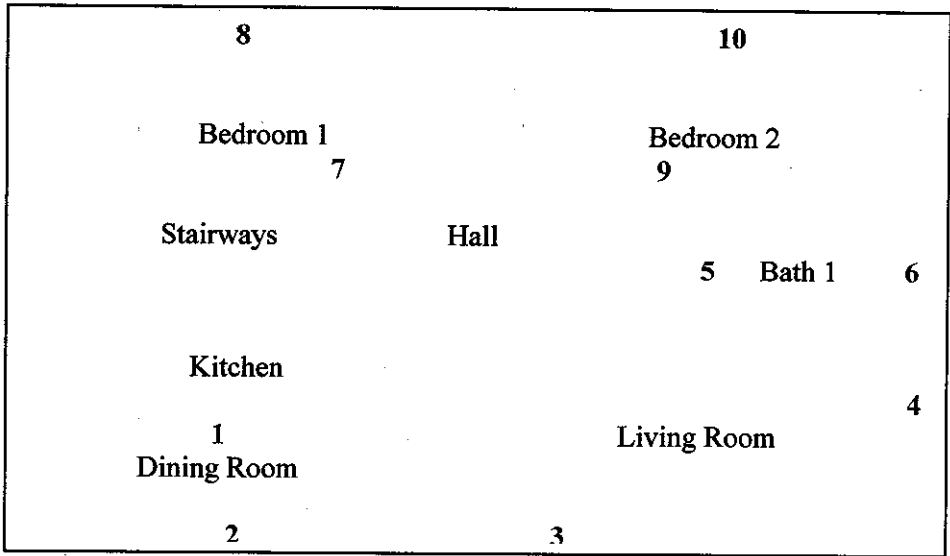
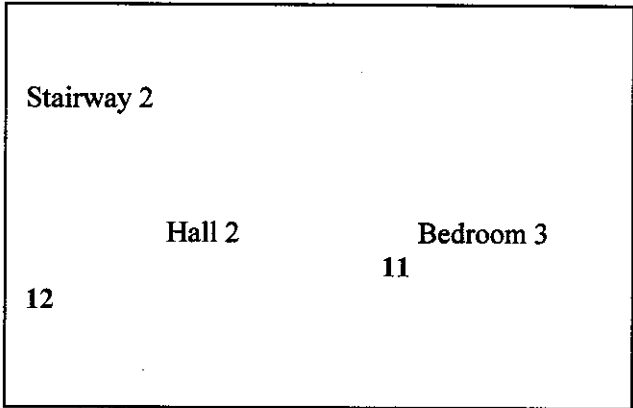
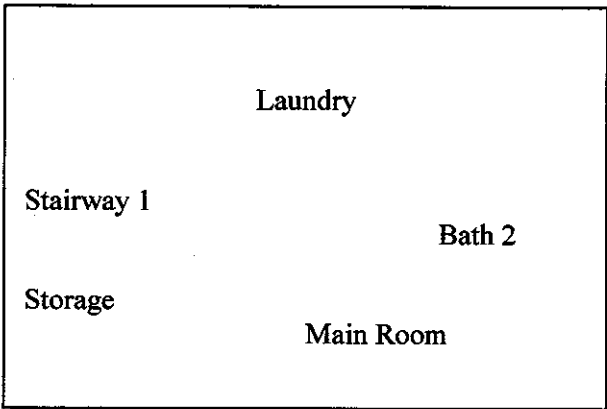
Attachment A: General Layout

A lead dust hazard was identified in window troughs, no other reportable LBP hazards were identified at this time.

Conclusion: *A lead dust hazard was identified in window troughs. Lead dust levels on other surfaces tested, i.e., floors and interior window sills, were below applicable standards.*

Treat deteriorated LBP on Window Trough Bedroom 1 (side 3) & Living room (side 4). See attached report.

- Conduct paint stabilization
- Eliminate the potential for friction/impact damage
- Conduct specialized cleaning of any lead chips, dust & debris in work areas utilizing HEPA-vacuum & high phosphate detergent
