Port of Lake Charles

RE: 3501 Bayou D'Inde Road

200,000 Gallon EWT

ELEVATED TANK INSPECTION REPORT

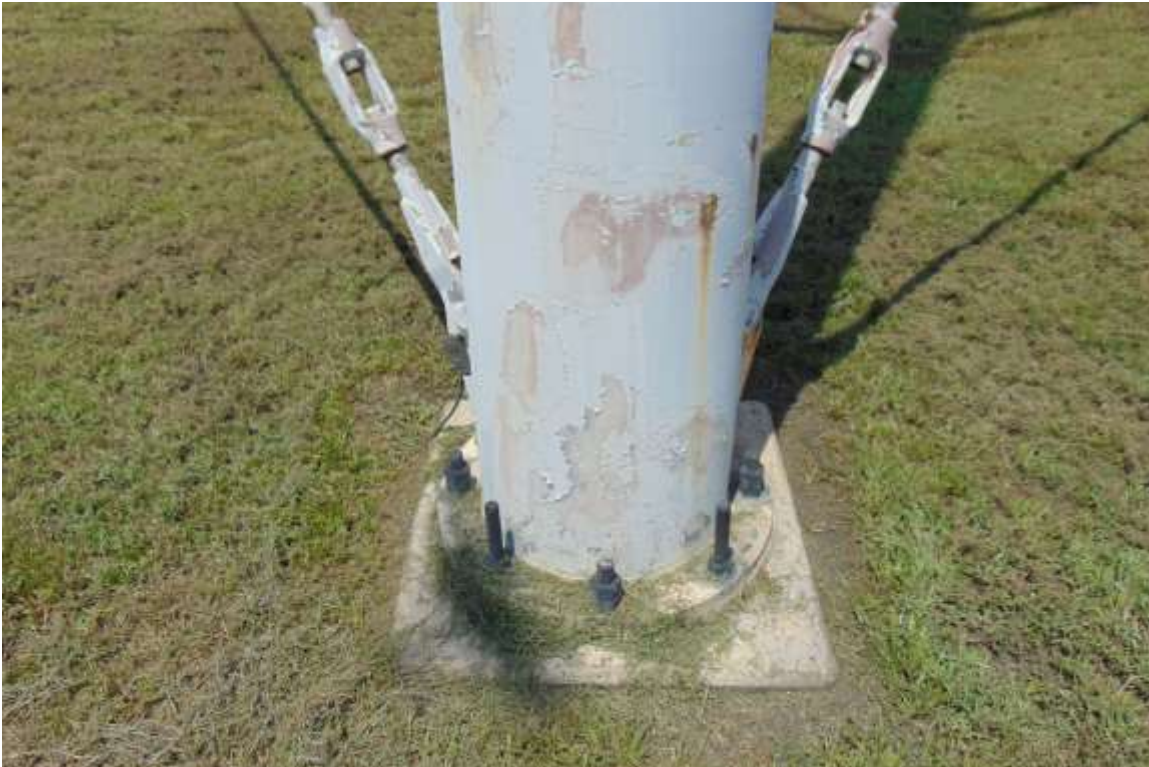
Photo shows the condition of the foundations. **NFPA 22-2013; 12.3.1** states, "The tops of foundation piers shall be level, shall be at least 6" (152 mm) above grade, and shall be located at the correct elevations." We recommend clearing any dirt, debris and other loose gravel away from the tank foundations, down to a minimum 6" below top of foundation. This should be done by a local excavating company.

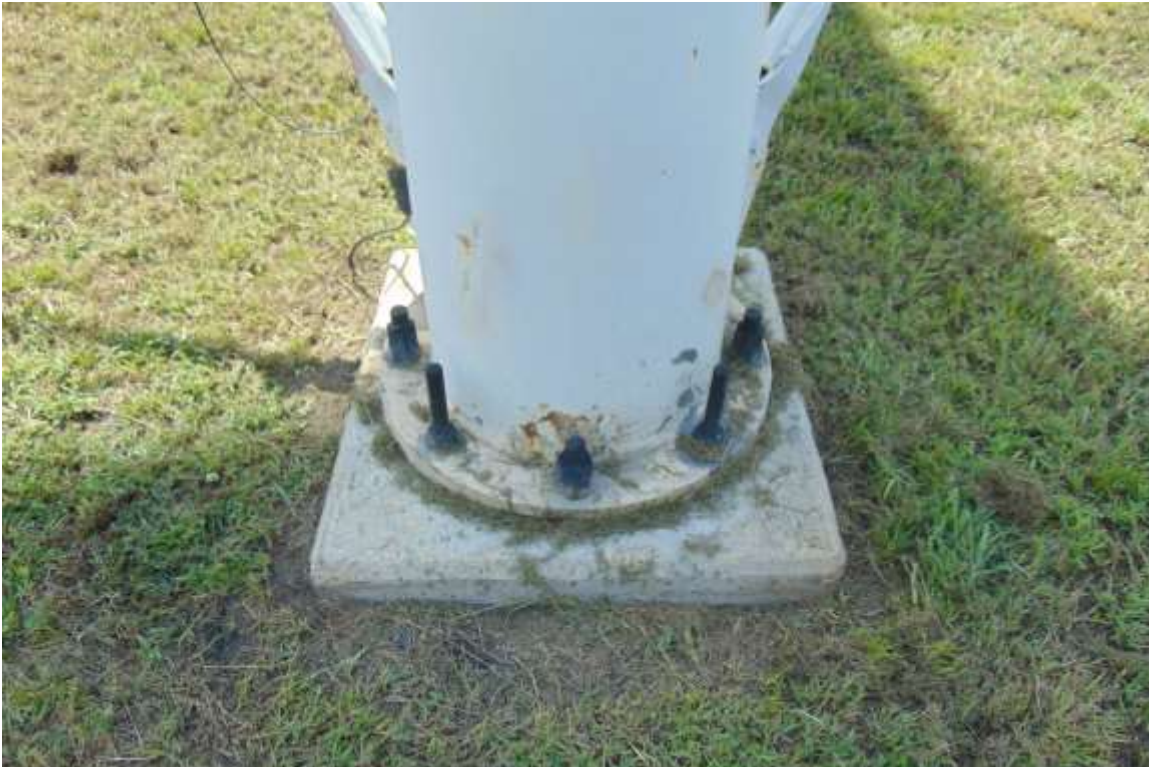
Photo shows the condition of the foundations. We recommend sealing the foundations with a sealant.

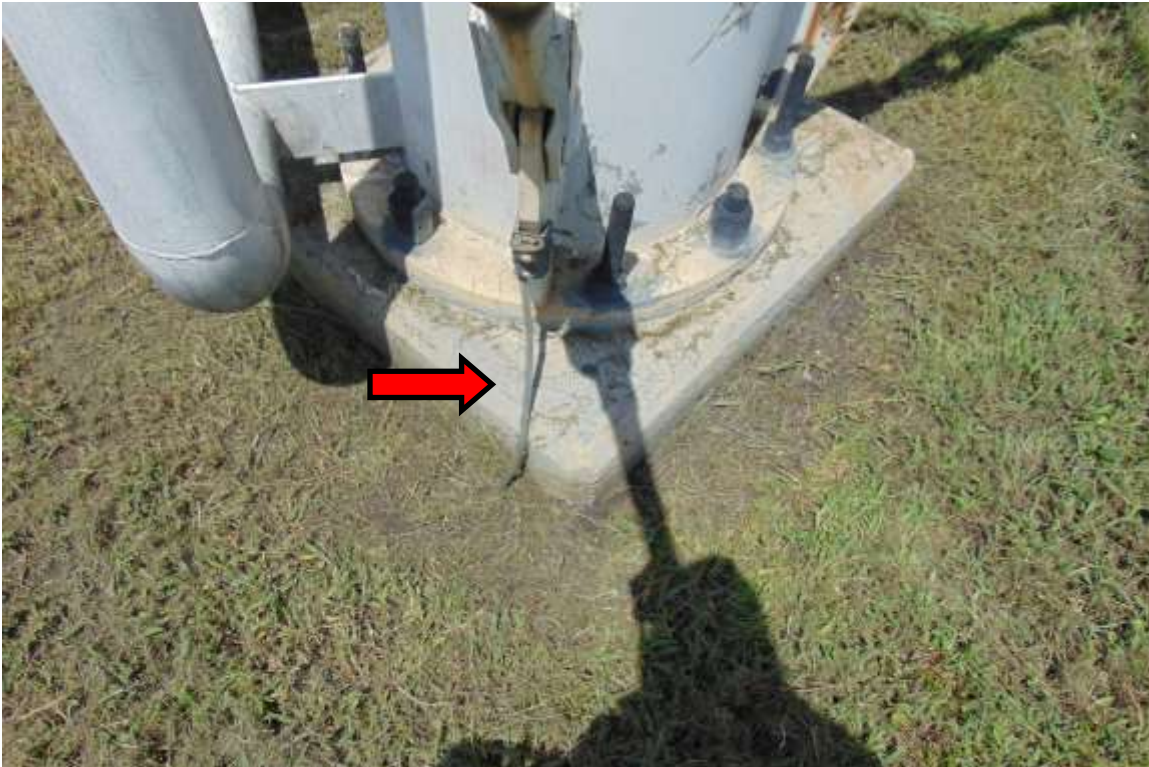
Photo shows the tank is electrically grounded for lightning protection as required by **OSHA 29 CFR 1926 (K)** and **NFPA 780-2014; 5.4: Metal Towers and Tanks** and appears to be in good condition.

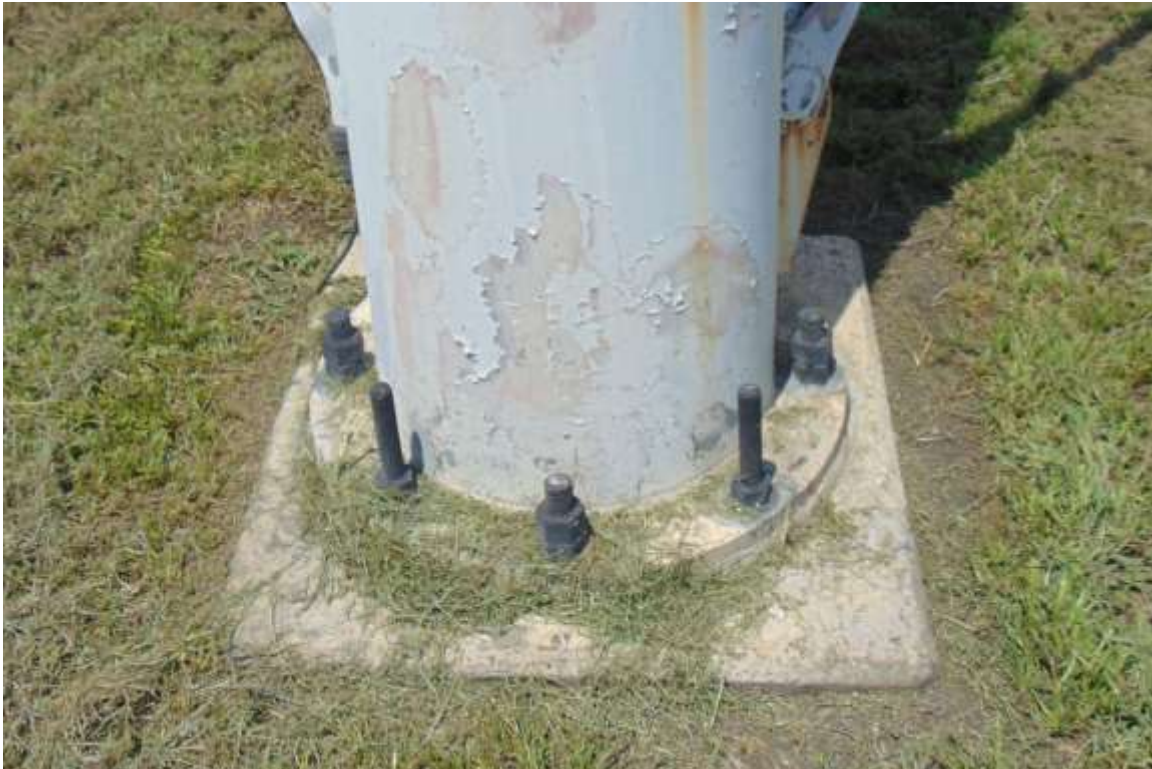
Photo shows the condition of the anchor bolts. The structural integrity of the anchor bolts should be maintained to withstand 100 mph winds blowing from any direction as required by **AWWA D100-11; 3.8: Anchorage**. We recommend cleaning the area around the anchor bolts, tightening the anchor nuts to specifications, then welding around the circumference of the nut-to-base plate connections and tack welding the bolt-to-nut connections for preventive maintenance.

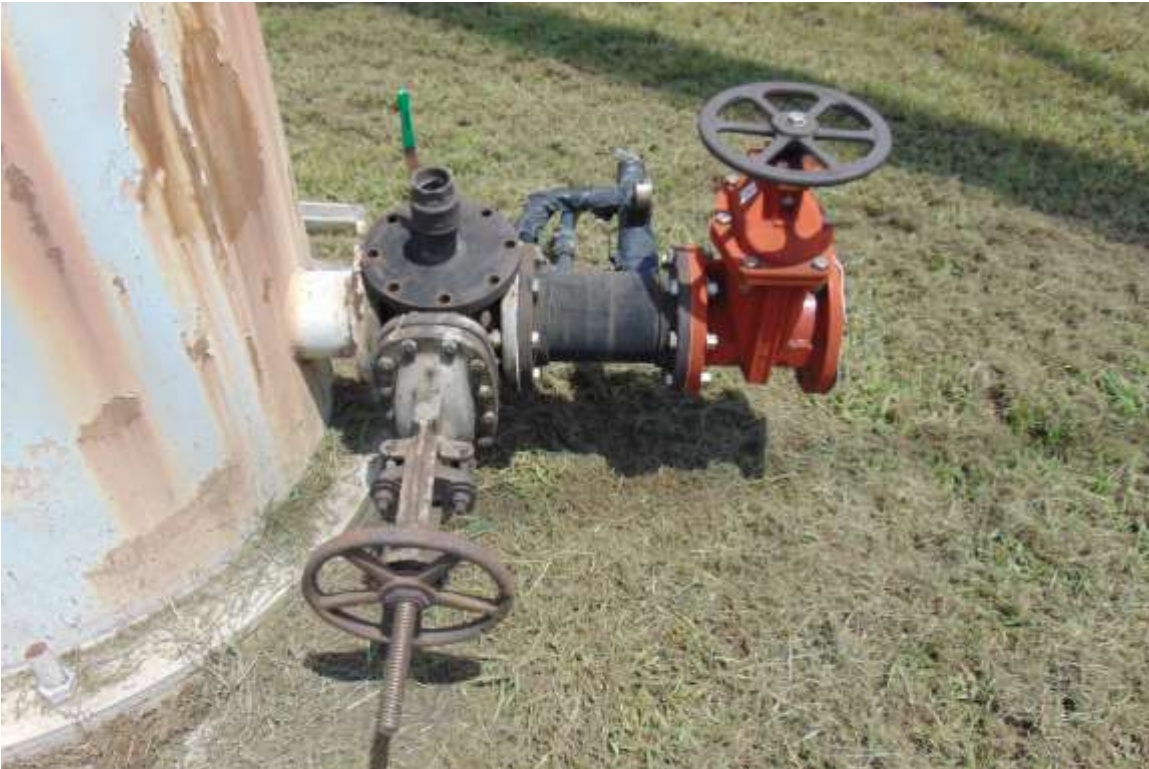
Photo shows the condition of the existing 6" drain valve. We recommend installing a locking device to prevent unauthorized draining of the tank and a splash pad to direct water away from the foundation.

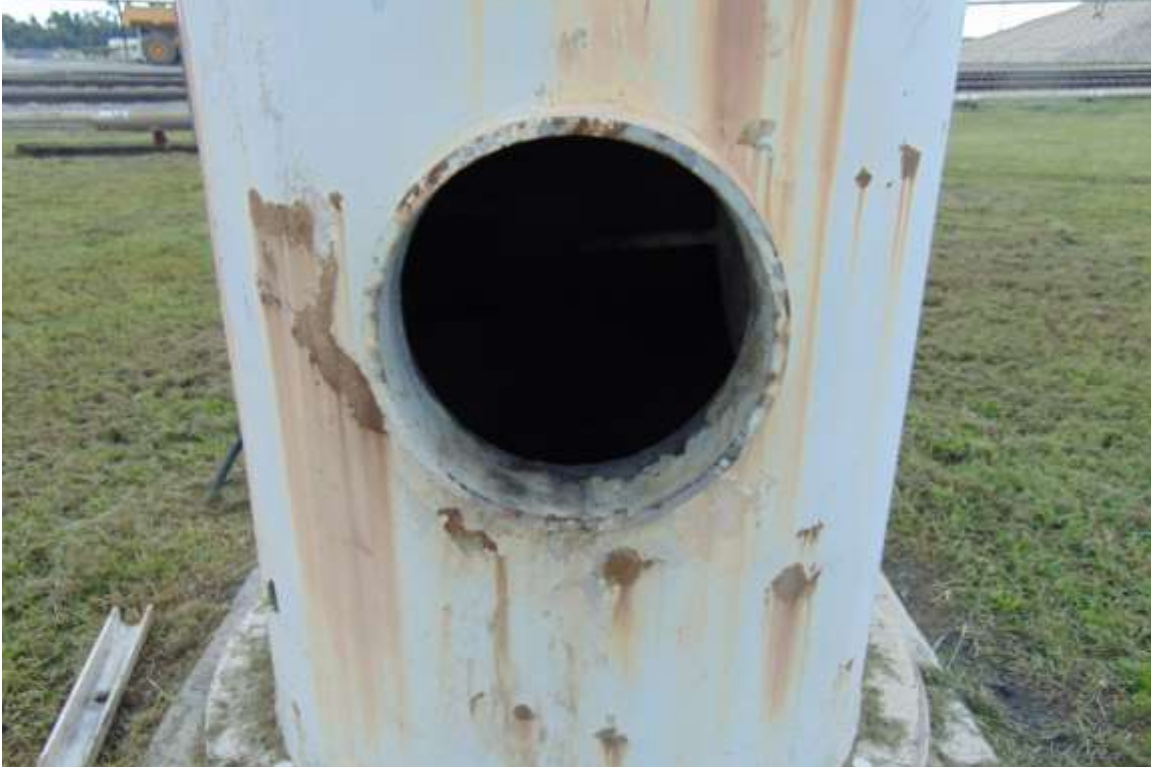
Photo shows the condition of the 18" riser manway. **This manway would restrict access in the case of an emergency.** We recommend replacing the existing riser manway with an **AWWA D100-11; 5.4.4 Steel Riser Manhole**, approved 24" manway, complete with davit arm and **Confined Space Entry** sign and maintenance free galvanized steel bolts.

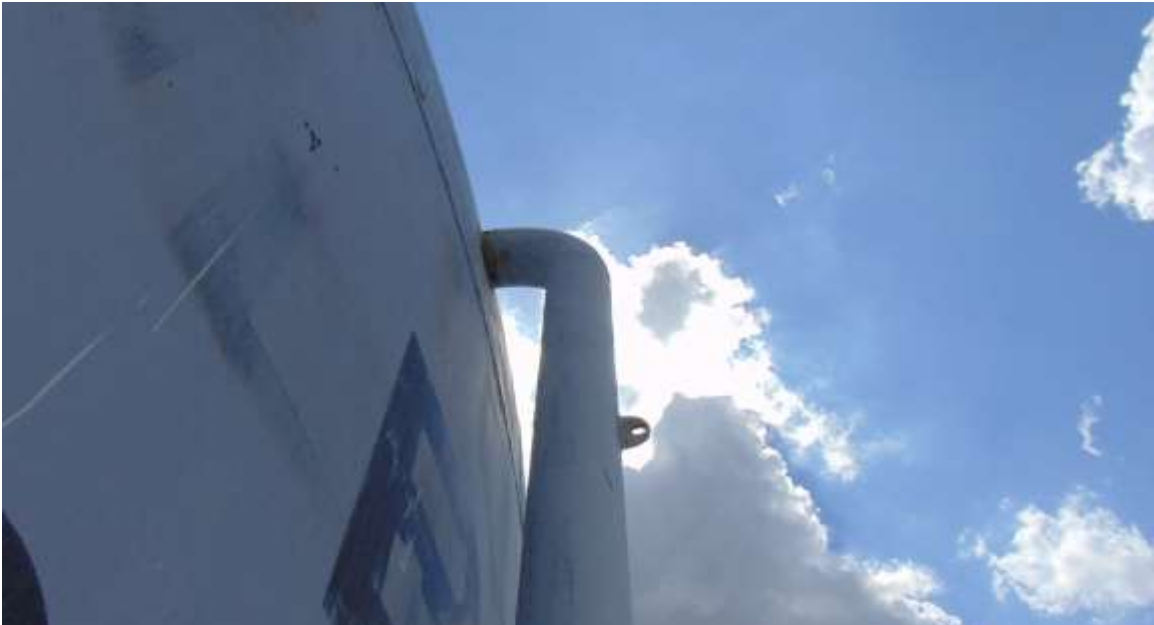
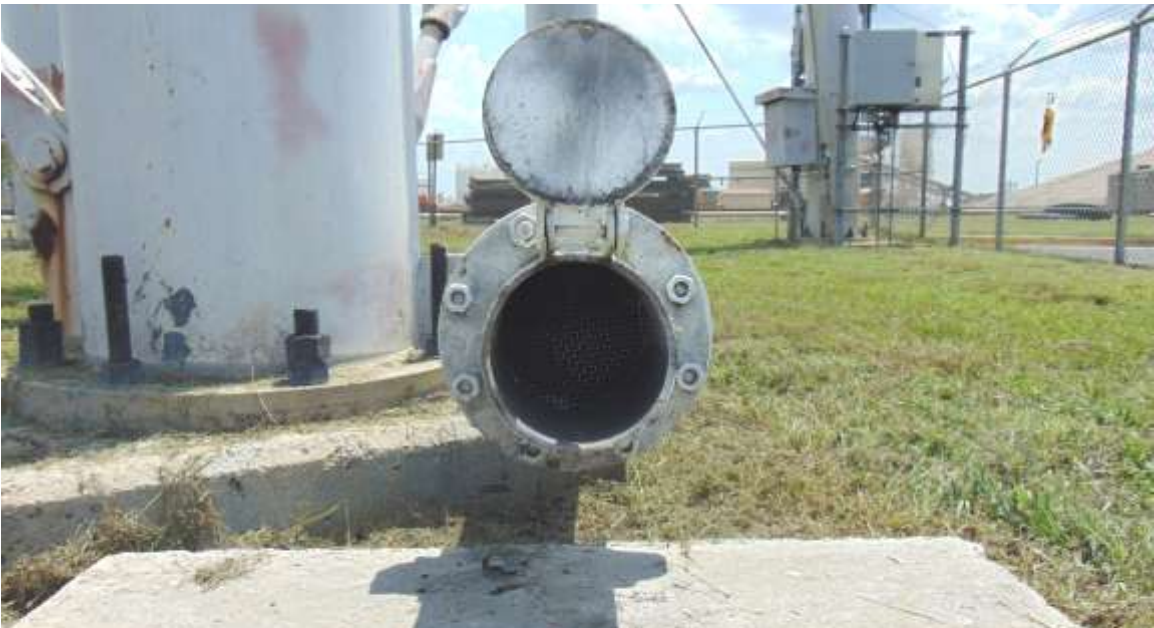
Photos show the condition of the 6" overflow pipe system. It appears to be in good condition.

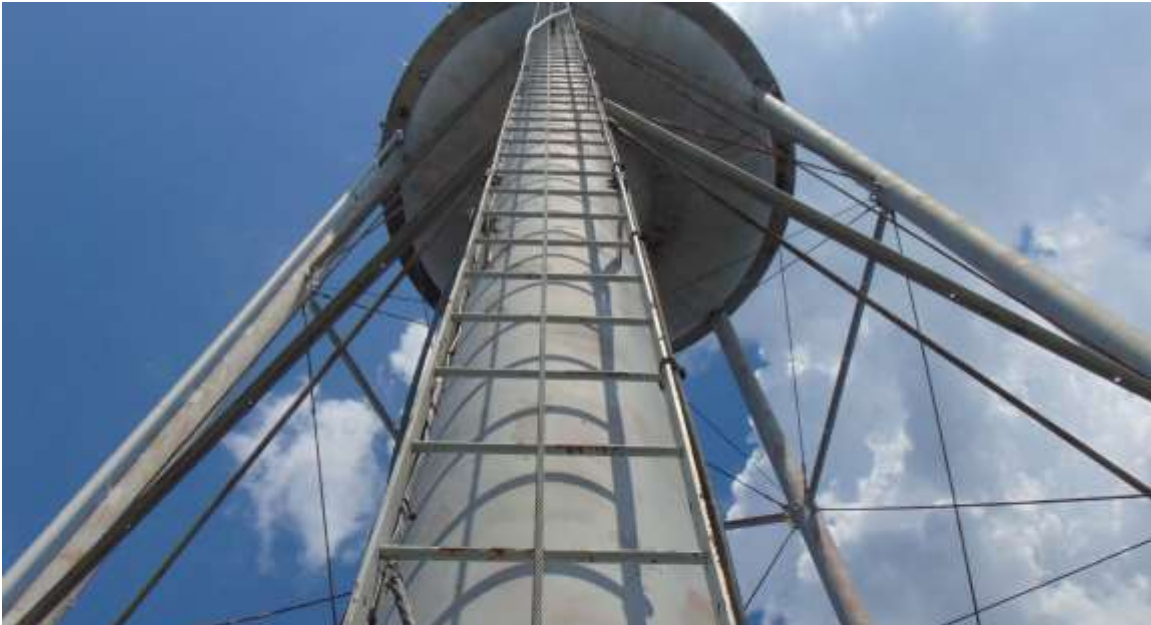
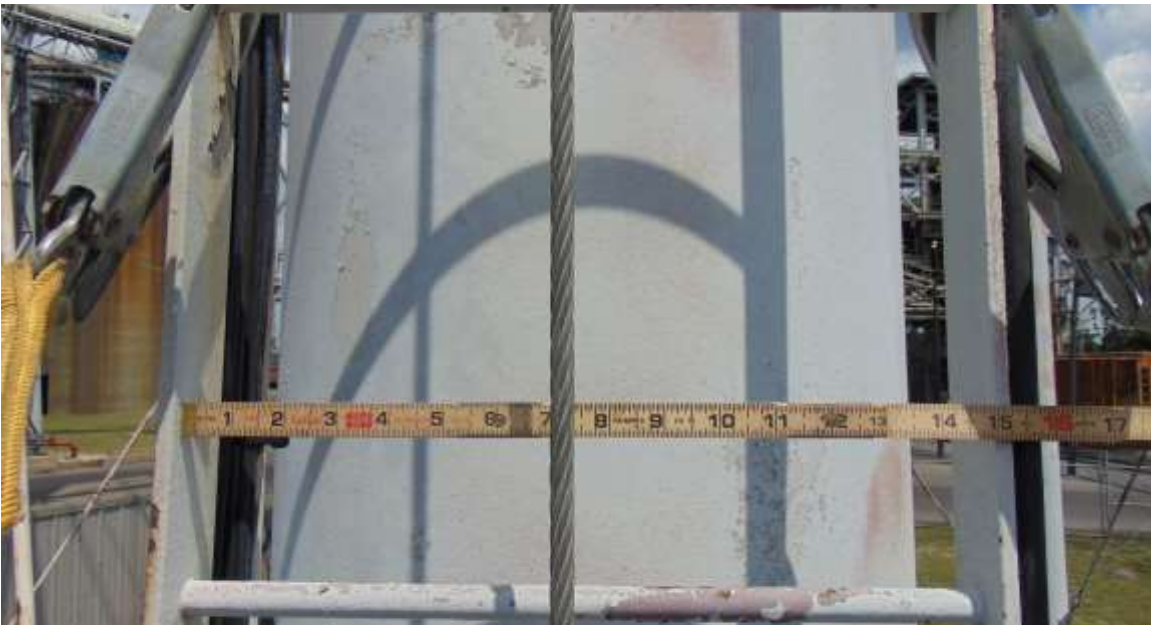
Tower access ladder in above photos is only 15" wide and is not equipped with anti-skid rungs. **OSHA 1910.27** states, "Rungs... must be corrugated, knurled, dimpled, coated with skid-resistant material or treated to minimize slipping." We recommend installing an **OSHA** compliant tower access ladder complete with standoffs every 10' on center, a cable type ladder safety device, a lockable ladder guard to prevent unauthorized access and posting a **Fall Protection Required** sign.

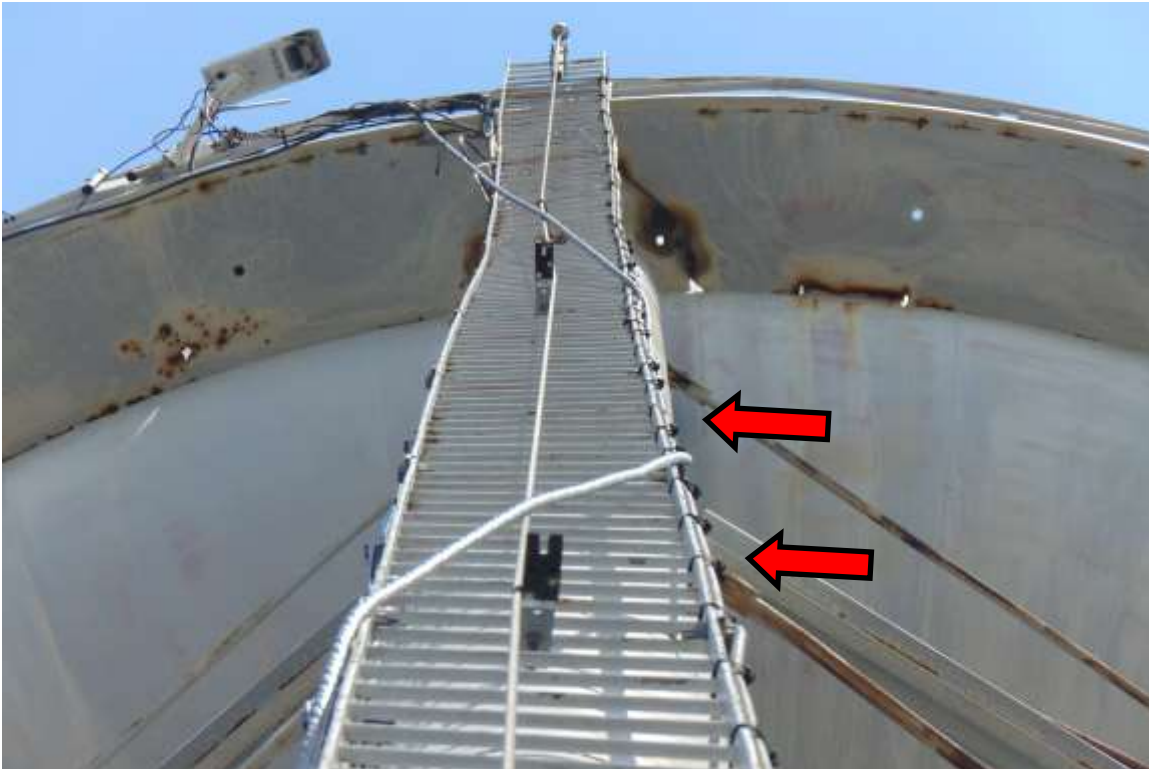
Photo shows more of the condition of the existing tower access ladder. Safe climbing procedure requires a person to climb a ladder with their hands on the side rails of the ladder and not the ladder rungs. **Notice a conduit is mounted on the ladder side rail, creating a climbing safety hazard.** We recommend removing the conduit from the ladder and securing it, with standoffs to the support column to eliminate this climbing safety hazard.

11	Remove the conduit/co-ax from the ladder and secure it with standoffs to the tank shell to eliminate this climbing safety hazard.			X		
12	Adjust the windage rods and riser stay rods as needed, to withstand 100 mph winds blowing from any direction. This should be done on an emergency basis.	X			X	
13	Reinforce the strut ends by welding.				X	
15	Raise the existing handrail system to the required 42", install an intermediate rail, cut out a section of the handrail the width of the tower access ladder-- at the junction of the tower access ladder and structural girder; and install the necessary bracing to keep railing at design strength, complete with a swing gate at the newly-created opening in the handrail at the junction of the tower access ladder and structural girder.			X

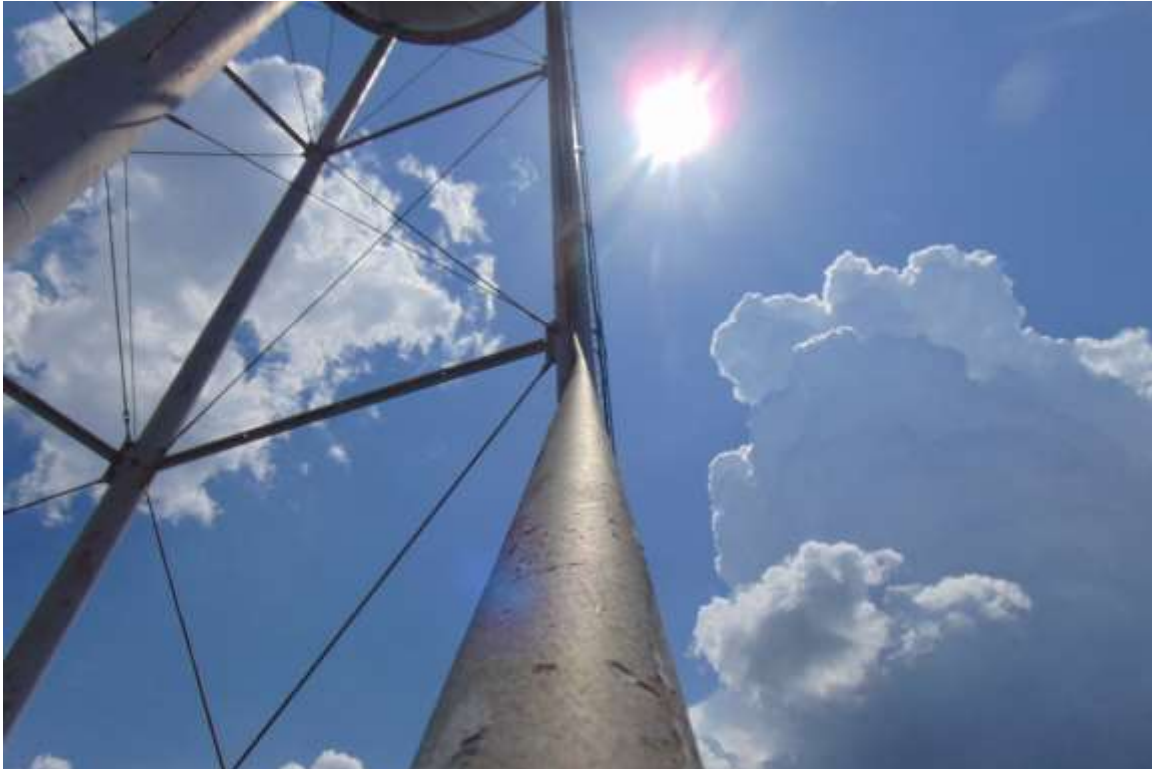
Photo shows the condition of the windage rods. The windage rods are designed to resist and stabilize the tower structure against wind and seismic loads combined with dead and live loads. The rods should withstand 100 mph winds blowing from any direction. **If the bracing remains loose, a sudden collapse could occur.** We recommend adjusting the windage rods and riser stay rods as needed, to withstand 100 mph winds blowing from any direction.

This work should be performed on an emergency basis.

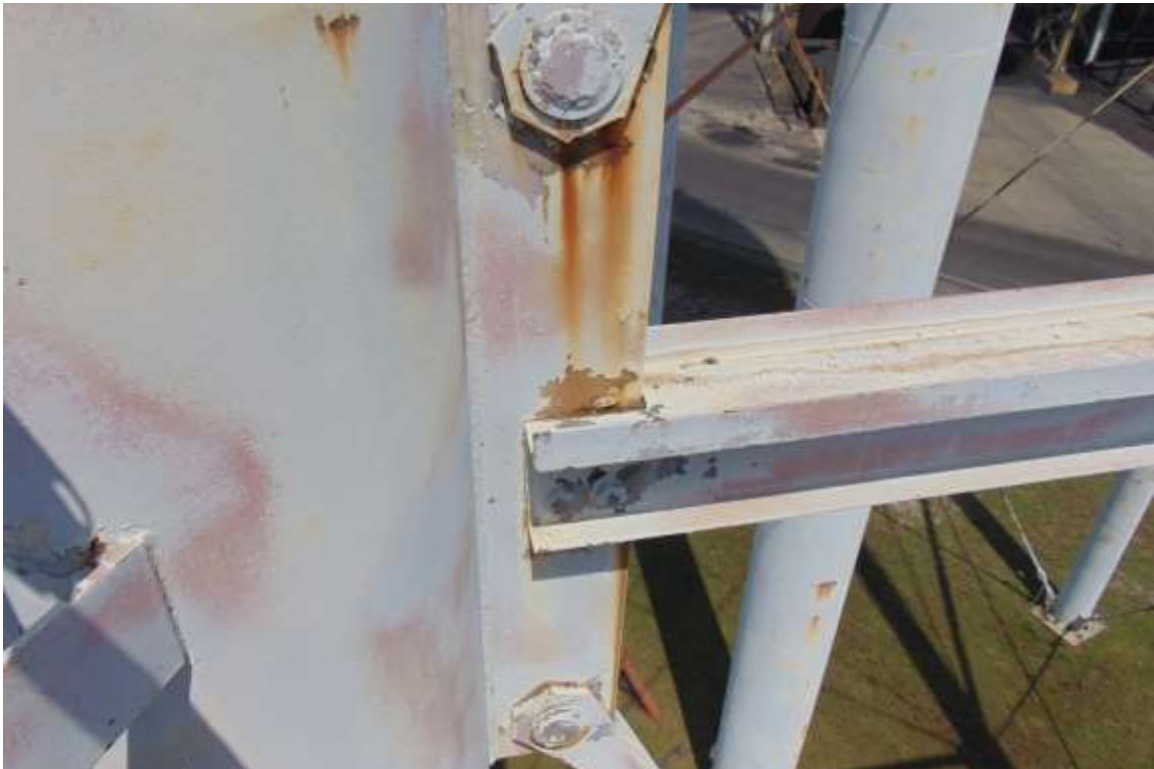
Photo shows the condition of the strut end connections. We recommend reinforcing the strut ends by welding.

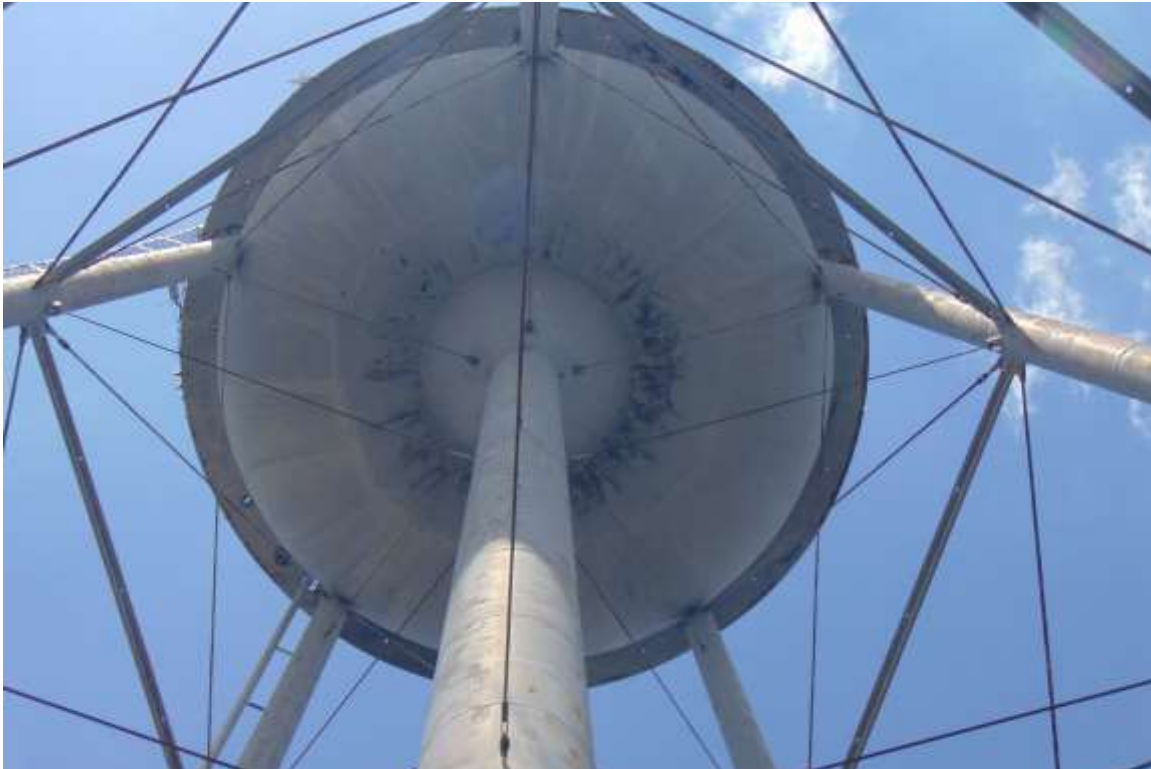
Photo shows the condition of the riser pipe and bowl. The connection appears to be in good condition.

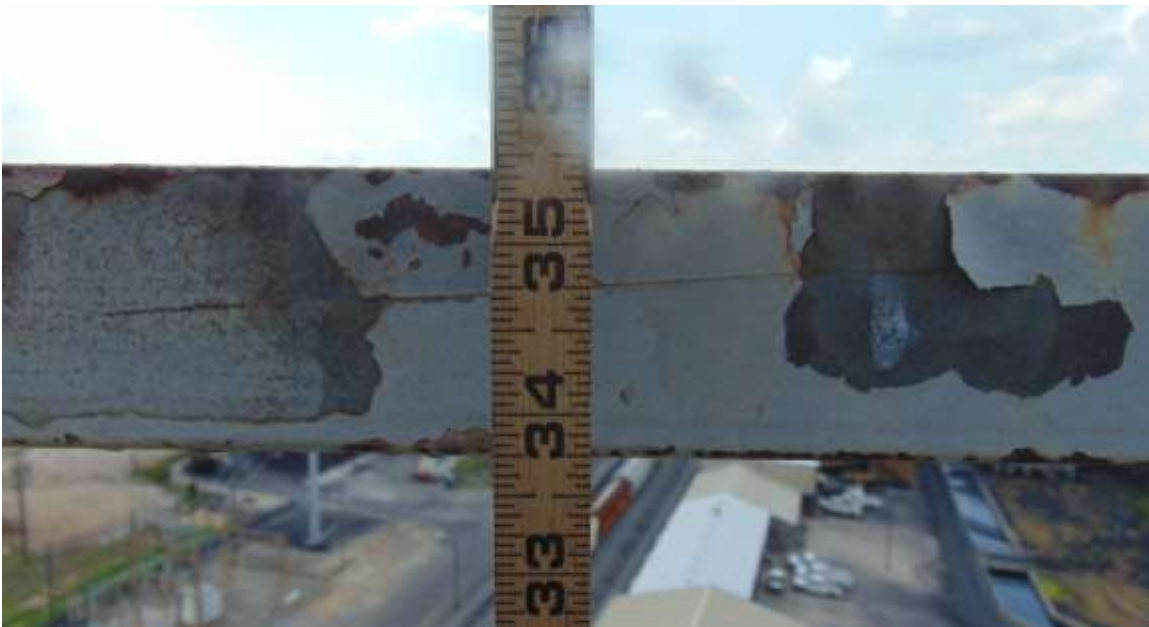
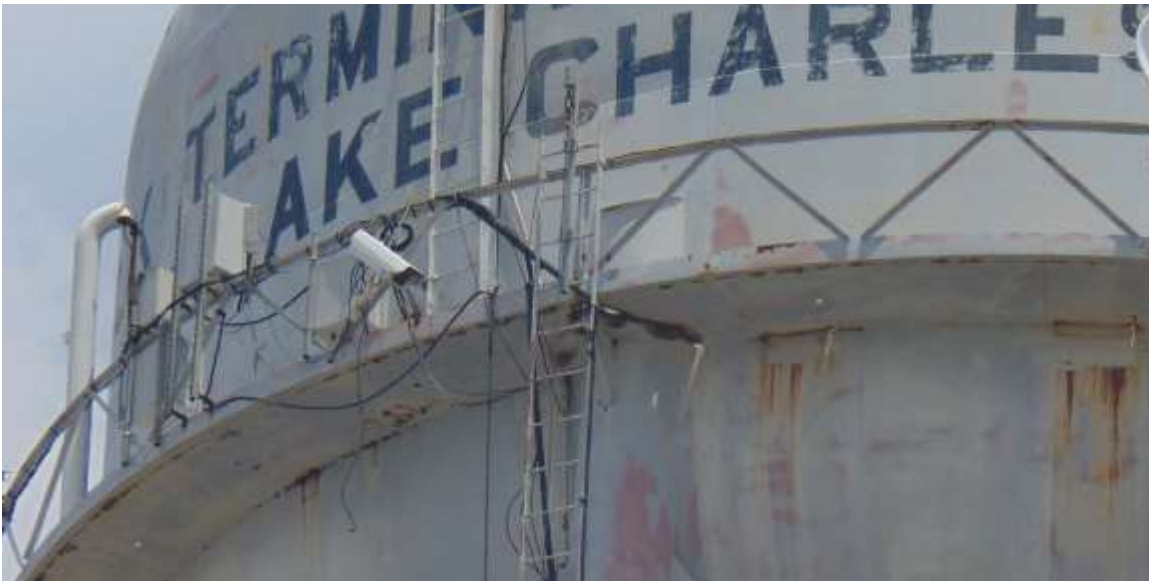
Photos show the condition of the existing handrail system. **NFPA 22-2013; 13.7.5.2** states, "A rigid railing at least 42" (1067 mm) high shall be provided around the outside of the balcony." The handrail is only 35" high and is not equipped with an intermediate rail. We recommend raising the existing handrail system to the required 42", installing an intermediate rail, cutting out a section of the handrail at the junction of the tower access ladder and structural girder, the width of the tower access ladder and installing the necessary bracing to keep railing at design strength, complete with a swing gate at the opening in the handrail at the junction of the tower access ladder and structural girder.

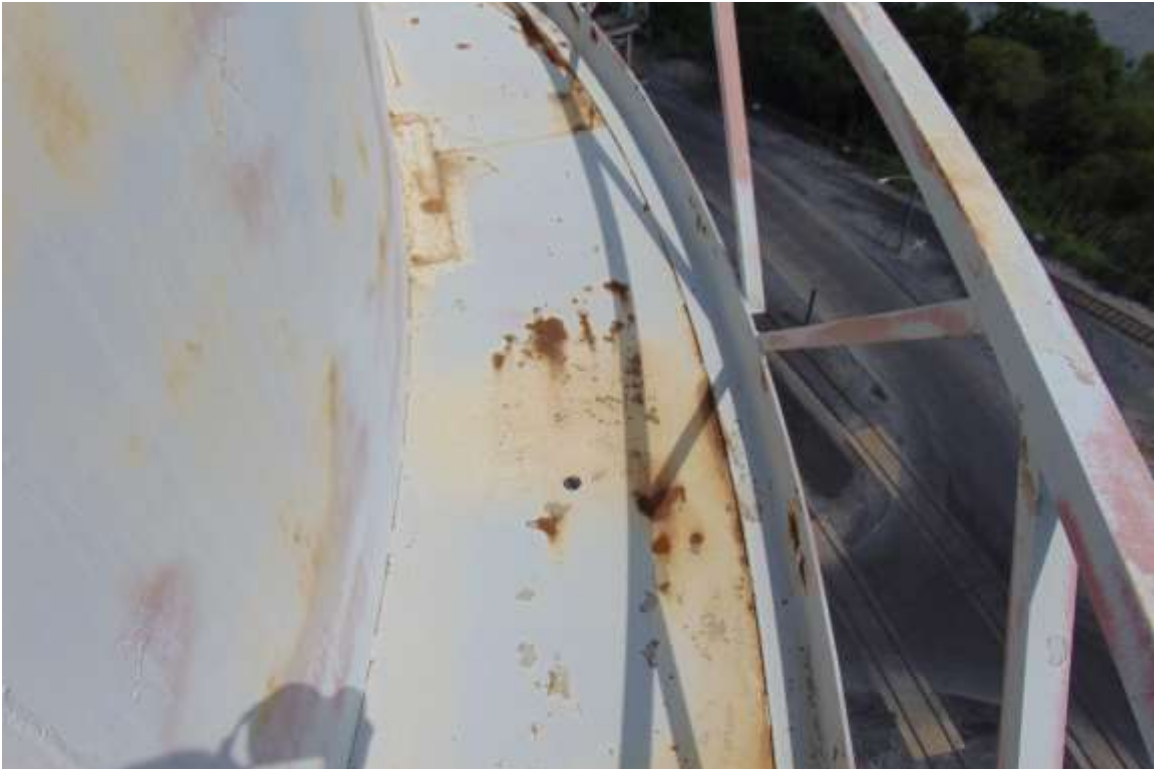
Photo shows where water is ponding on the balcony floor, causing deterioration of the paint and steel. We recommend drilling additional weep holes in the balcony floor to prevent ponding of water.

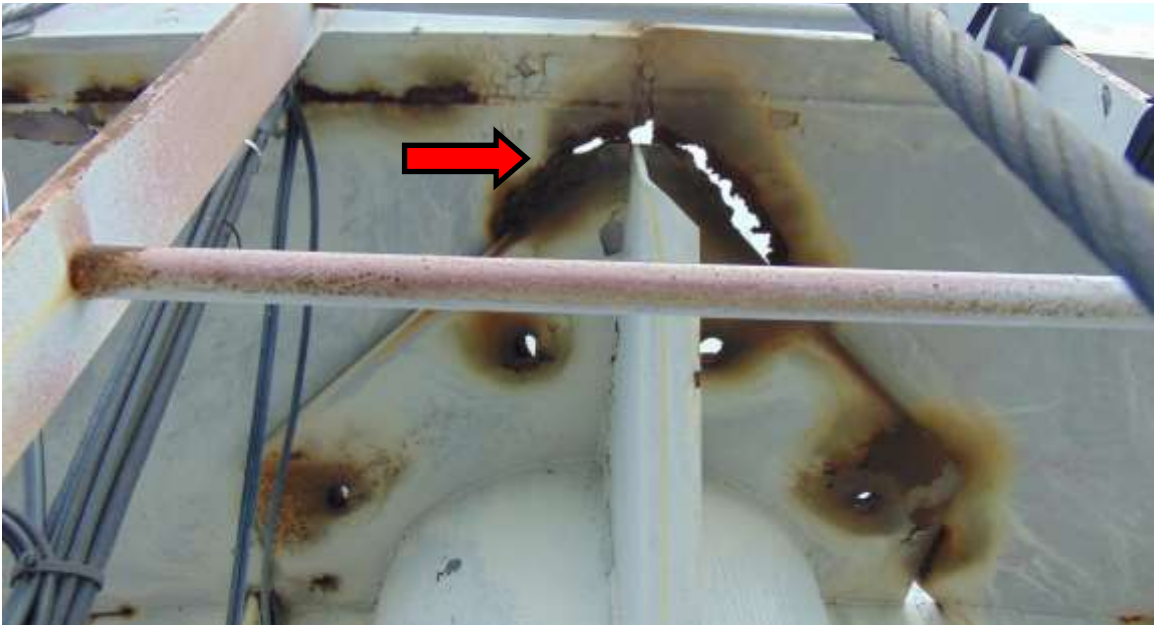
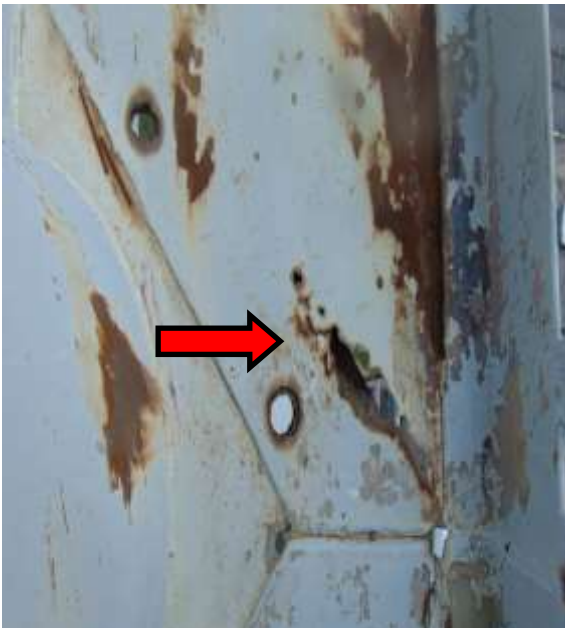
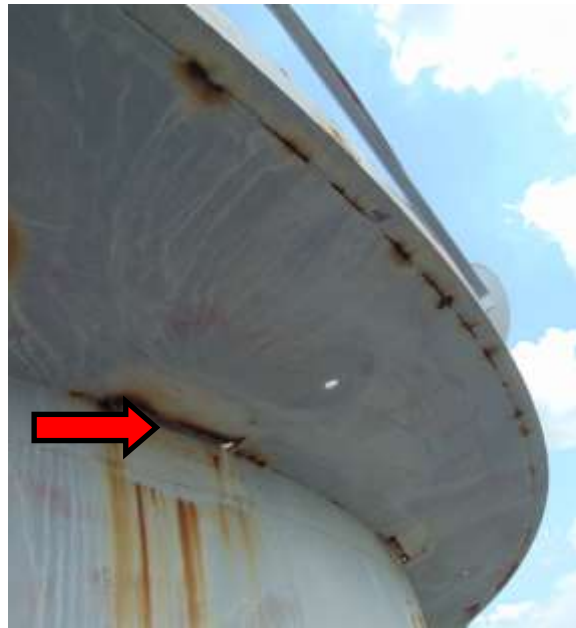
Photos show underneath the tank catwalk where the metal is deteriorating. We recommend welding steel patch plates over the affected areas.

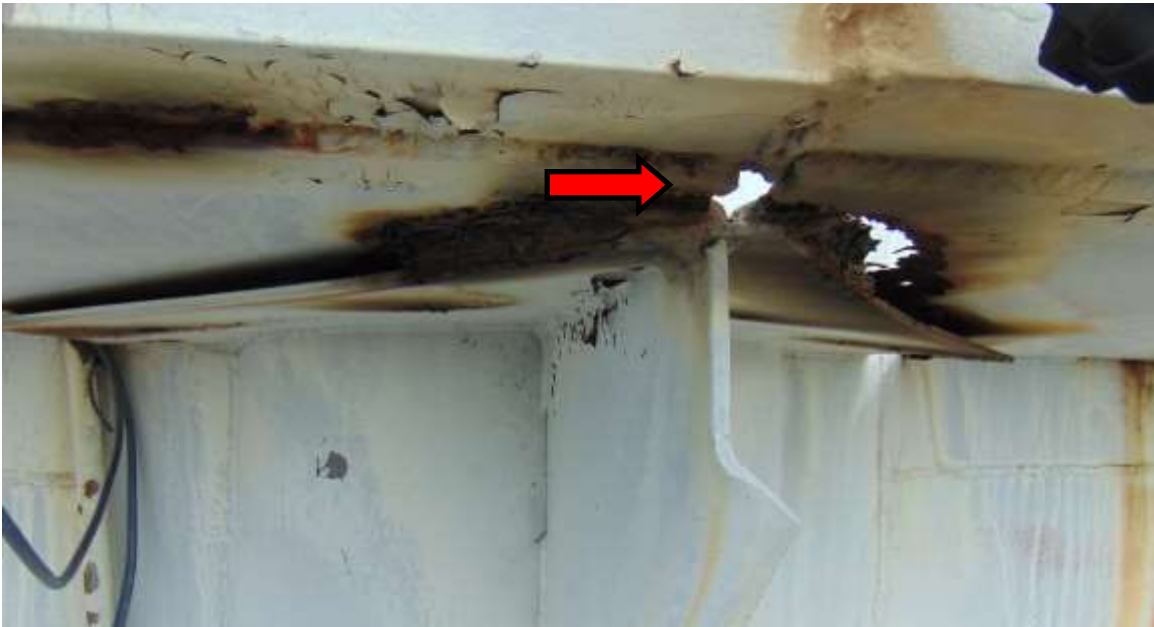
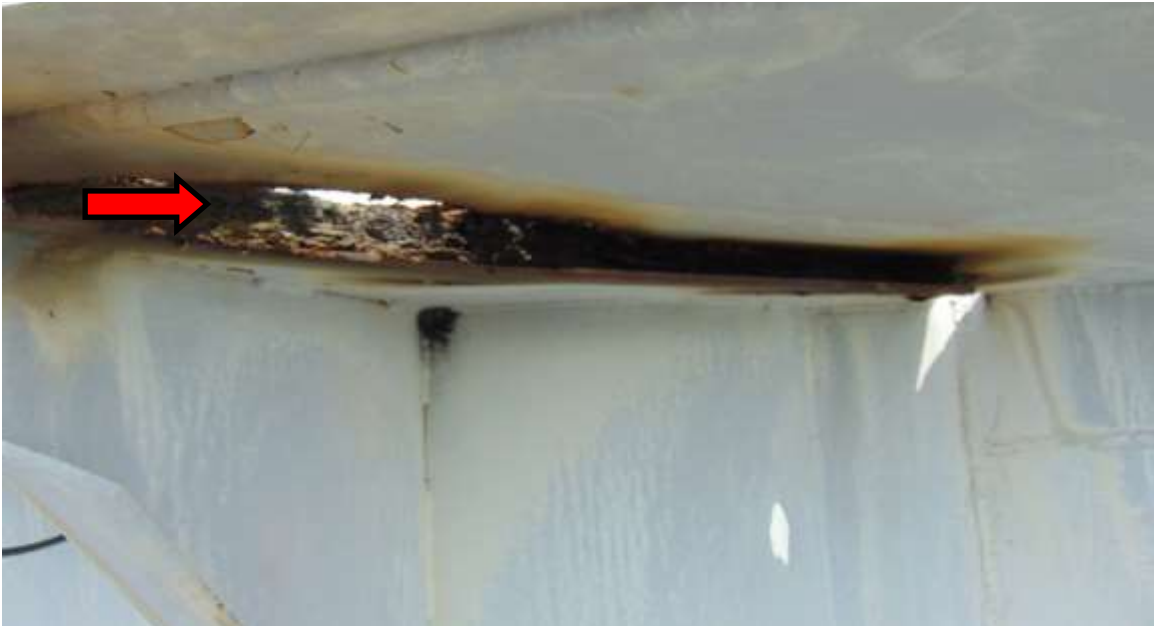
More photos of the deterioration.

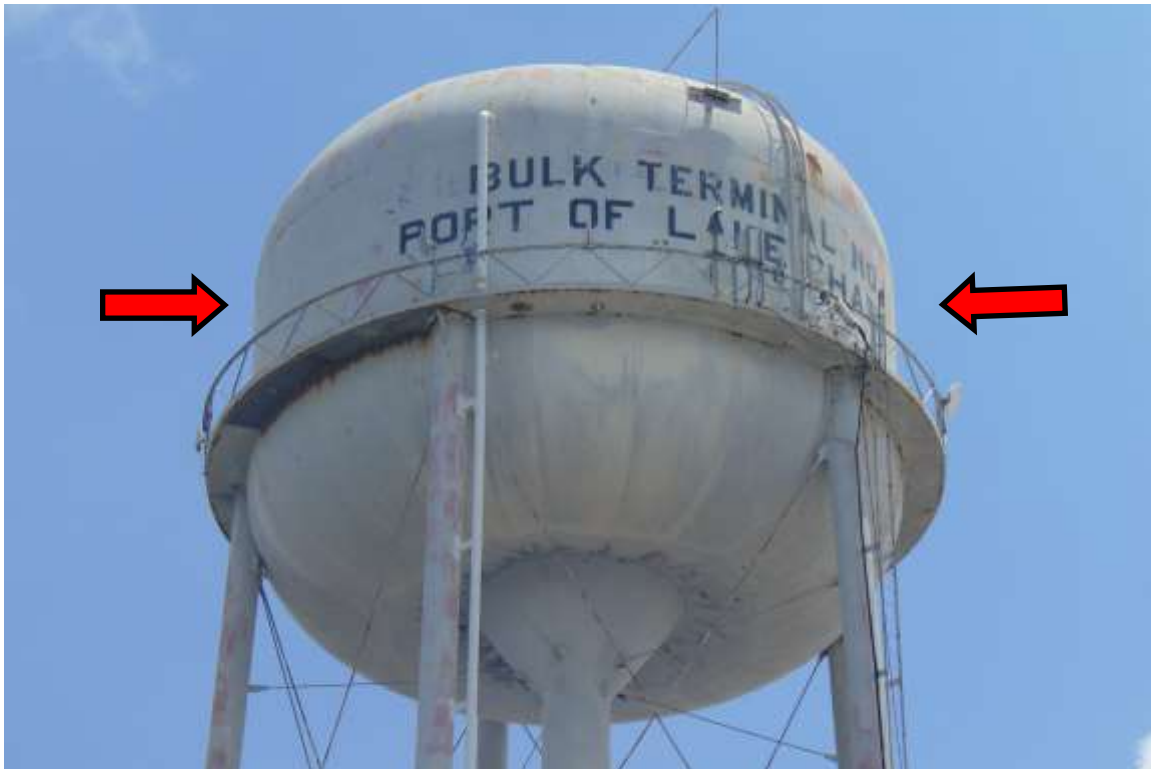
Photo shows the condition of the tank shell. Shell manways installed on this tank will be in compliance with **NFPA 22-2013; 14.7.2: Shell manholes**, and **OSHA 1910.146 (c) (2): Confined Spaces**.

We recommend :

Install two (2) 30" shell manways 180° apart
Install davit slides on both manways
Post **Confined Space Entry** signs

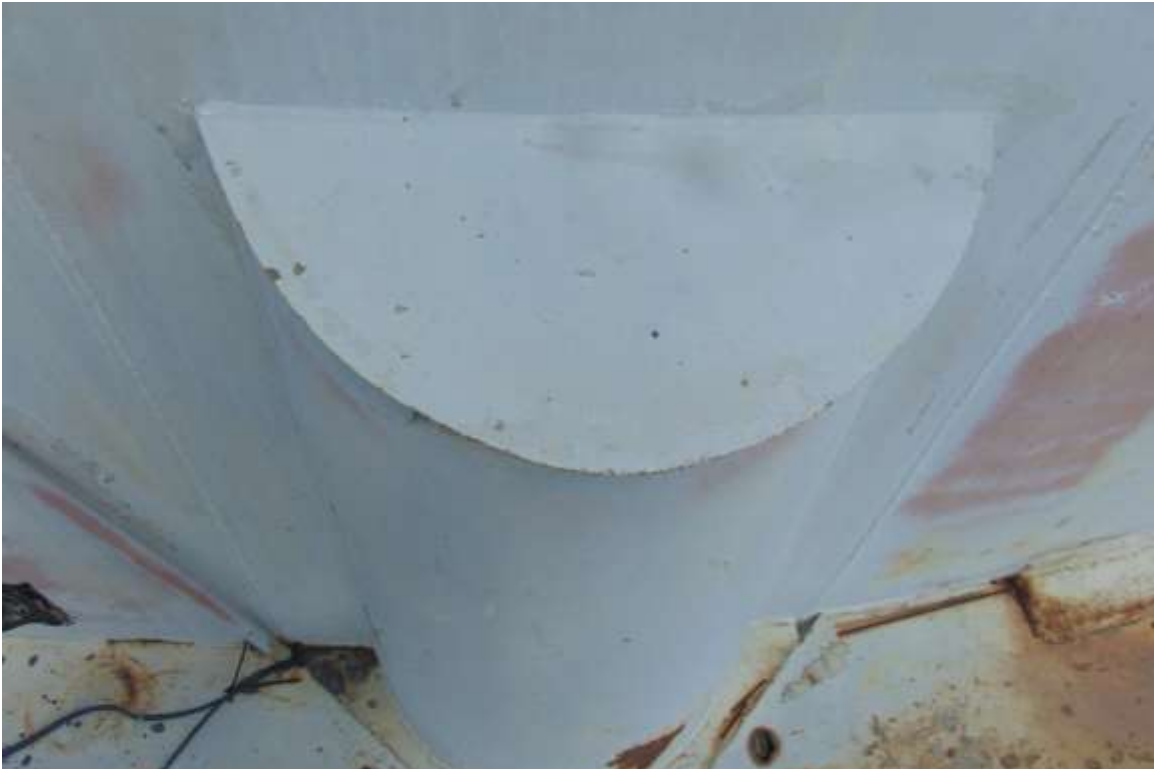
Photo shows the condition of the posthead connections. The postheads secure the column legs to the tank shell and support the tank's live and dead load. The postheads have been welded around the circumference of the posthead-to-shell connection for reinforcement and appear to be in good condition.

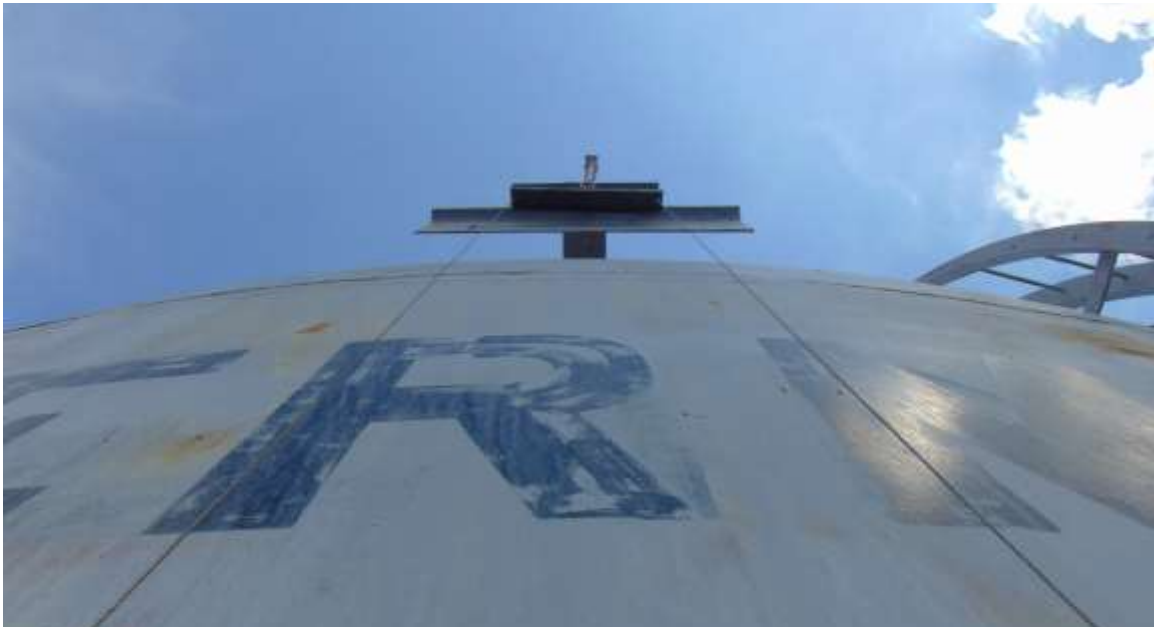
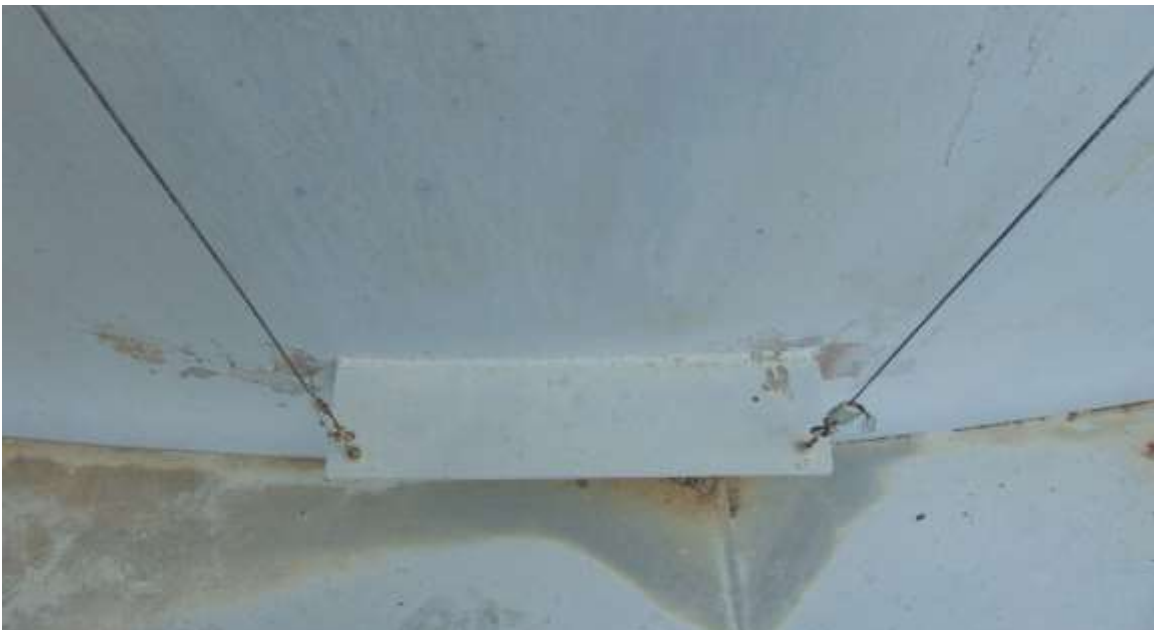
Photos show the condition of the liquid level indicator. **NFPA 25-2014; 9.3.1** requires liquid level indicators shall be tested every 5 years for accuracy and freedom of movement. We recommend cleaning and lubricating all moving parts on the liquid level indicator for preventative maintenance, then adjusting and calibrating the unit.
