Port of Lake Charles

RE: 3501 Bayou D'Inde Road

200,000 Gallon EWT

ELEVATED TANK INSPECTION REPORT

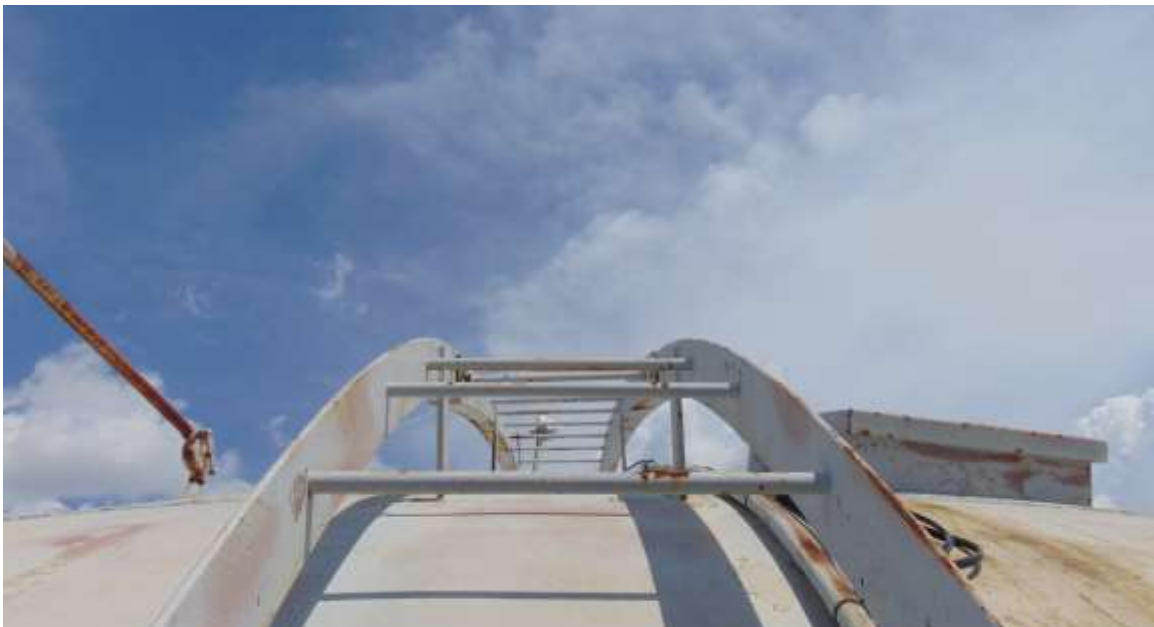
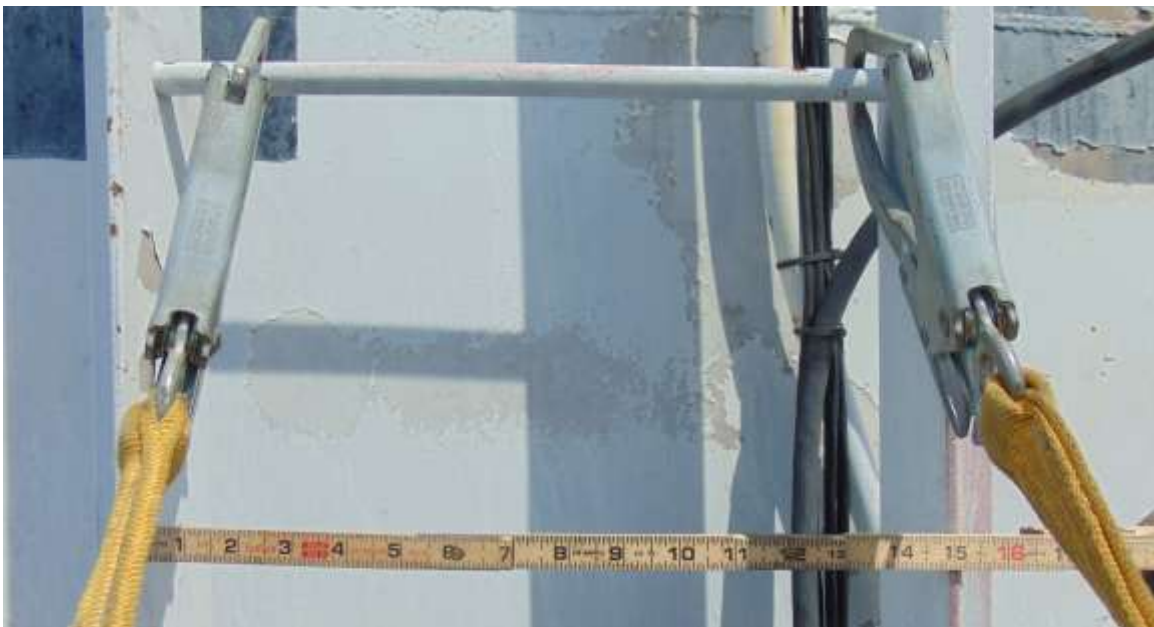
Shell/roof access ladder in above photos is not equipped with anti-skid rungs and is only 15" wide. **OSHA 1910.27** states: "Rungs... must be corrugated, knurled, dimpled, coated with skid-resistant material or treated to minimize slipping "We recommend installing a anti-skid rung equipped, shell ladder complete with standoffs every 10' on center and a cable type ladder safety device.

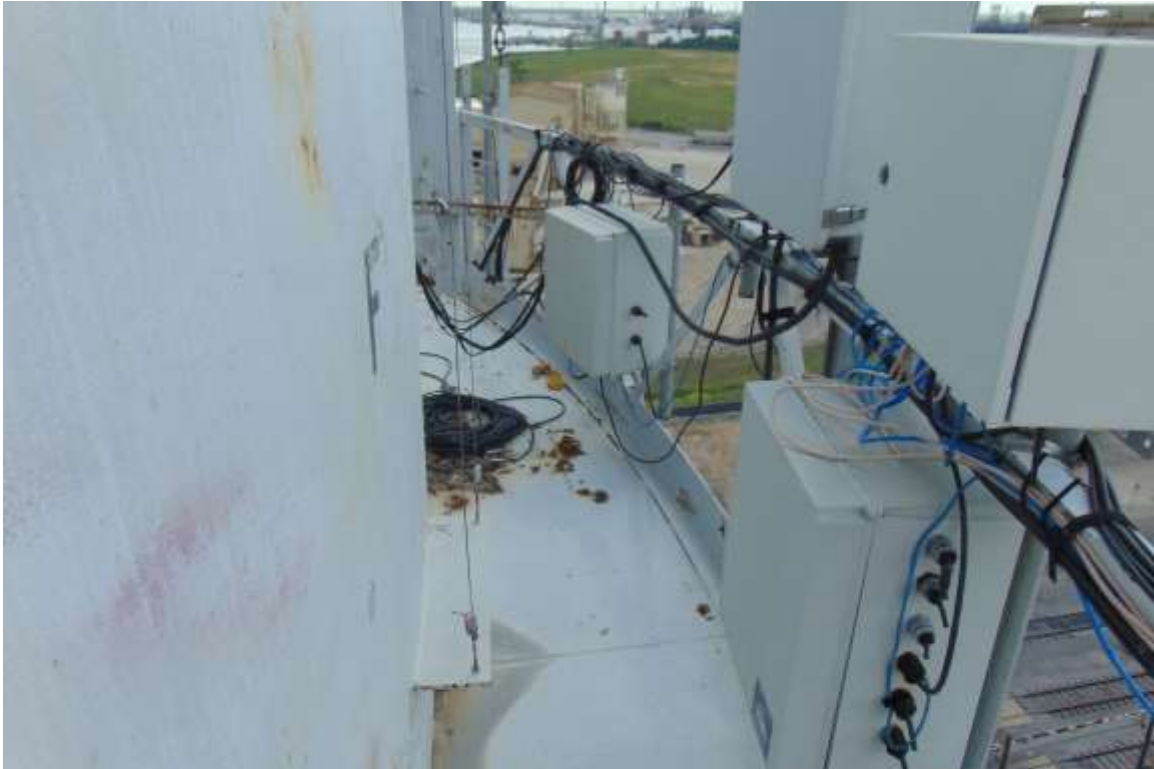
Photo shows the antenna system located on top of the tank. We recommend performing a structural analysis to determine whether or not the tank can support the weight of the antenna system.

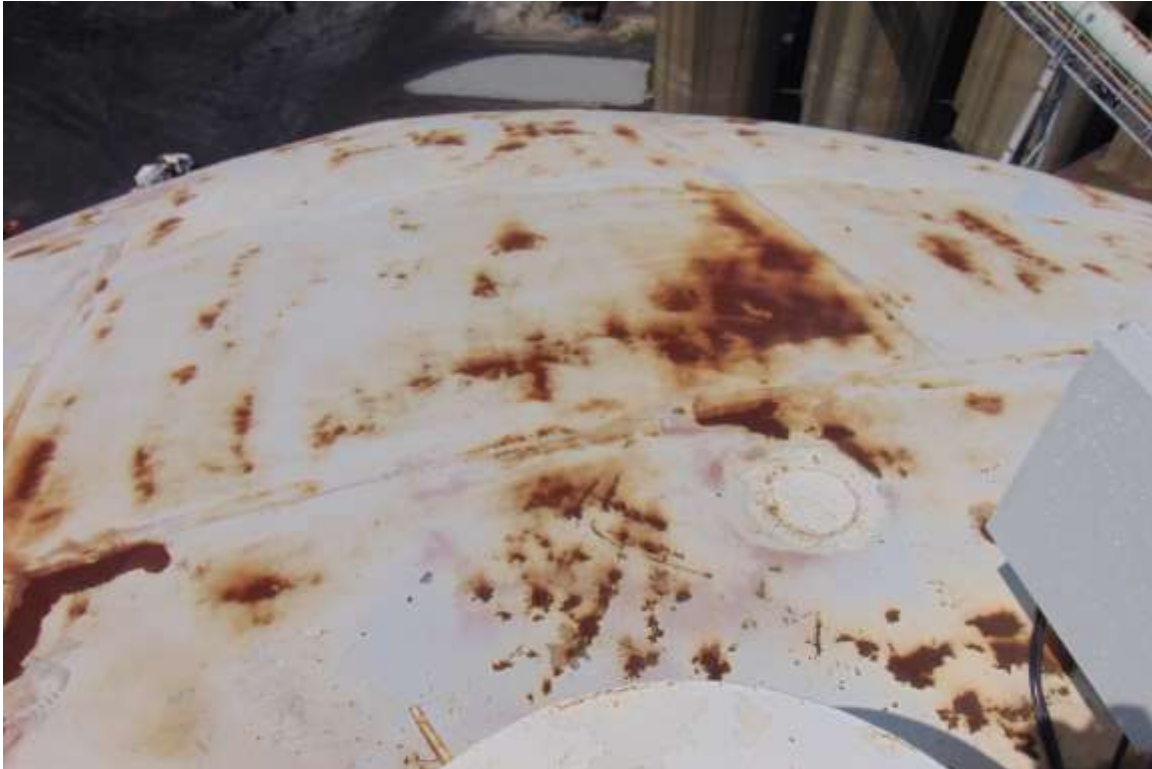
Photo shows that the roof is not equipped with a required fall protection system. **OSHA 1910.23 (c)** requires fall protection on the edges of all walking working surfaces. We recommend installing a 42" high handrail system around the circumference of the tank roof, complete with toeboard, intermediate rail and a swing gate at the junction of the shell-to-roof access ladder and tank roof.

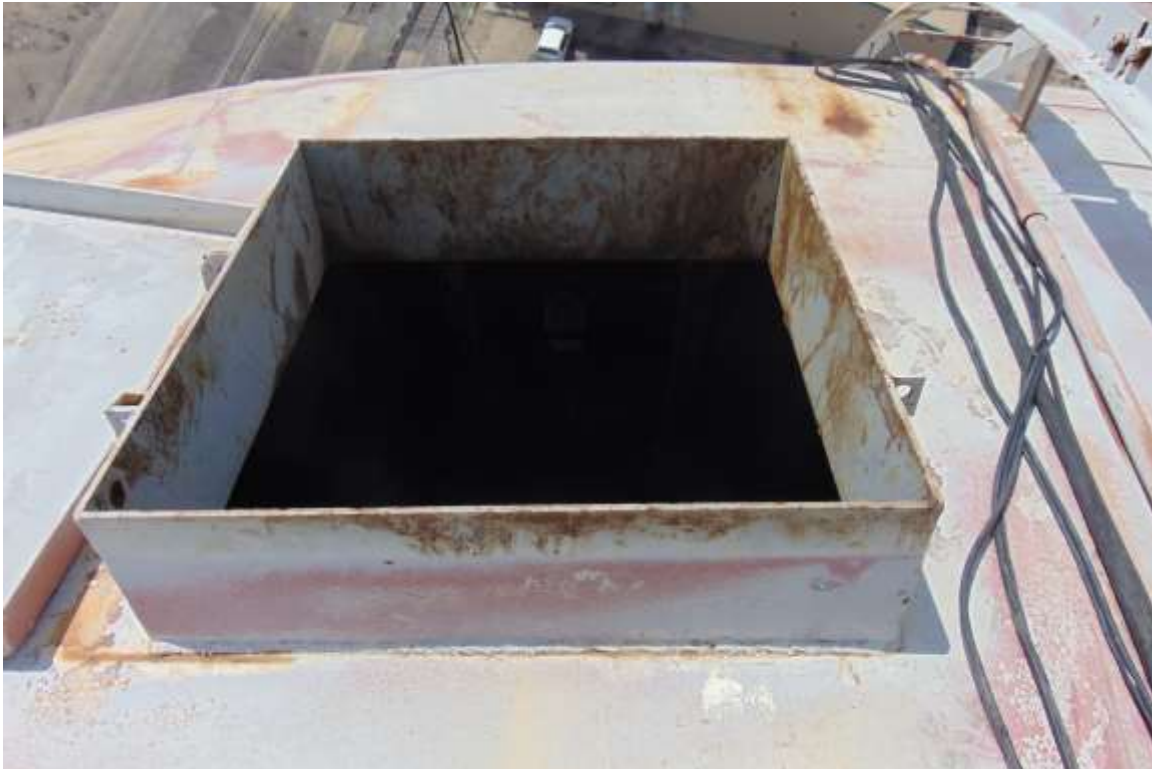
Photo shows the condition of the 24" existing roof manway. Roof openings on this tank require the following to be in compliance with **OSHA 1910.146 (c) (2)**, **AWWA D100-11; 5.4.3:** and **NFPA 22-2013; 5.7.3: Roof Hatch.**

We recommend:

Install 30" secondary roof manway 180° from primary manway
Post **Confined Space Entry** signs
Install new lock on existing manway

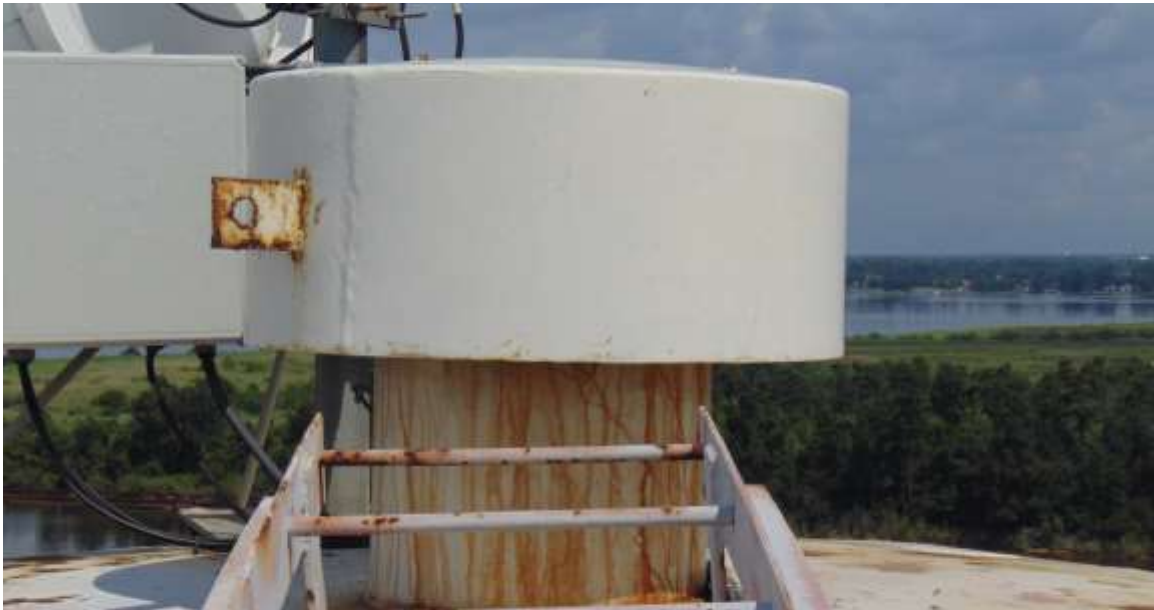
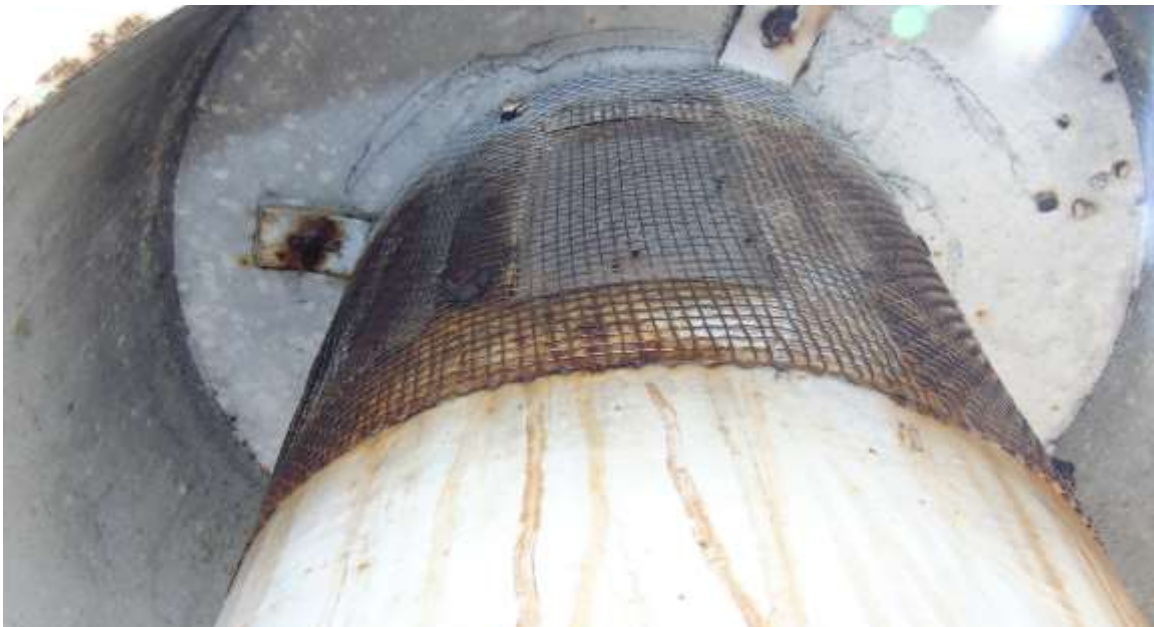
Photos show the condition of the existing 16" roof vent. **NFPA 22-2013; 4.15 Roof Vent.** An improperly vented tank may cause external pressure to act on the tank which can cause buckling even at low pressure differential. We recommend replacing the existing roof vent with a vacuum-pressure vent and screen.

This work should be performed on an emergency basis.

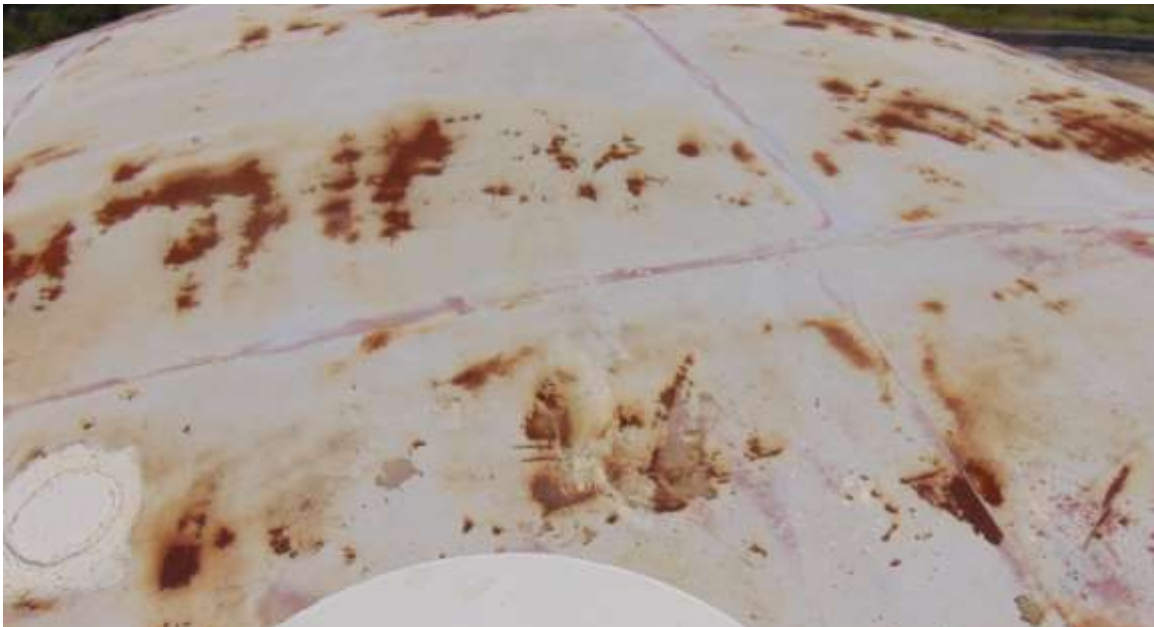
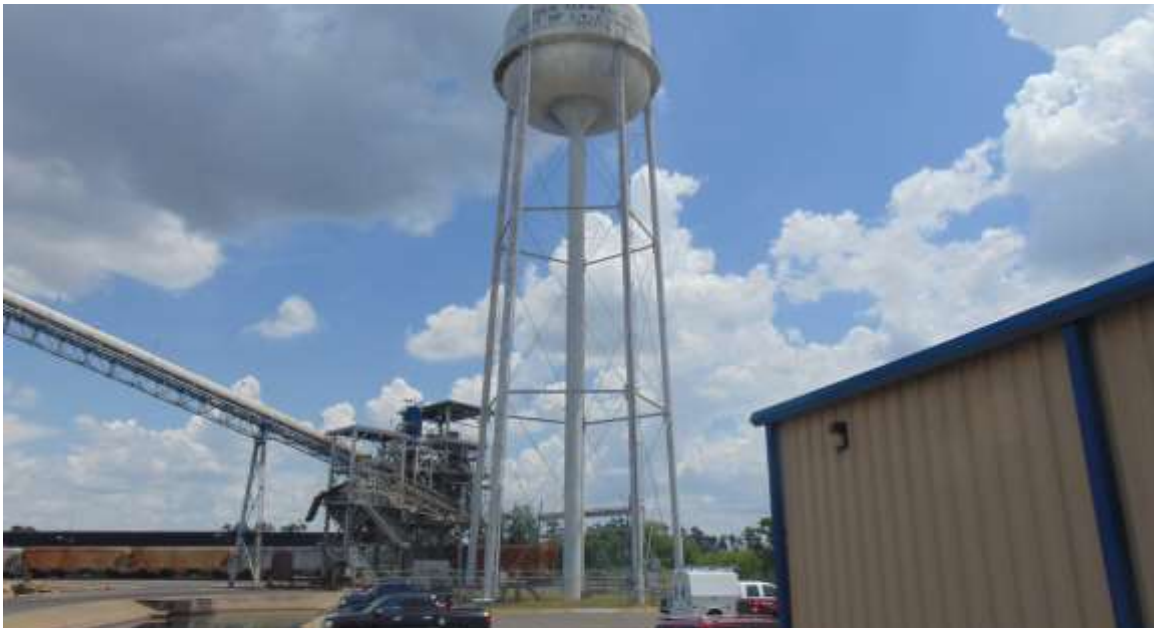
Photos show the tank exterior coating system. We recommend pressure washing the tank exterior with biodegradable detergent injection (minimum 3,500 psi at 3.0 gpm) then remove all loose rust and scale with wire brushes and hand scrapers in accordance with SSPC #2 (hand tool cleaning), spot prime and apply one (1) finish coat of alkyd enamel, this includes replacing the existing logo.

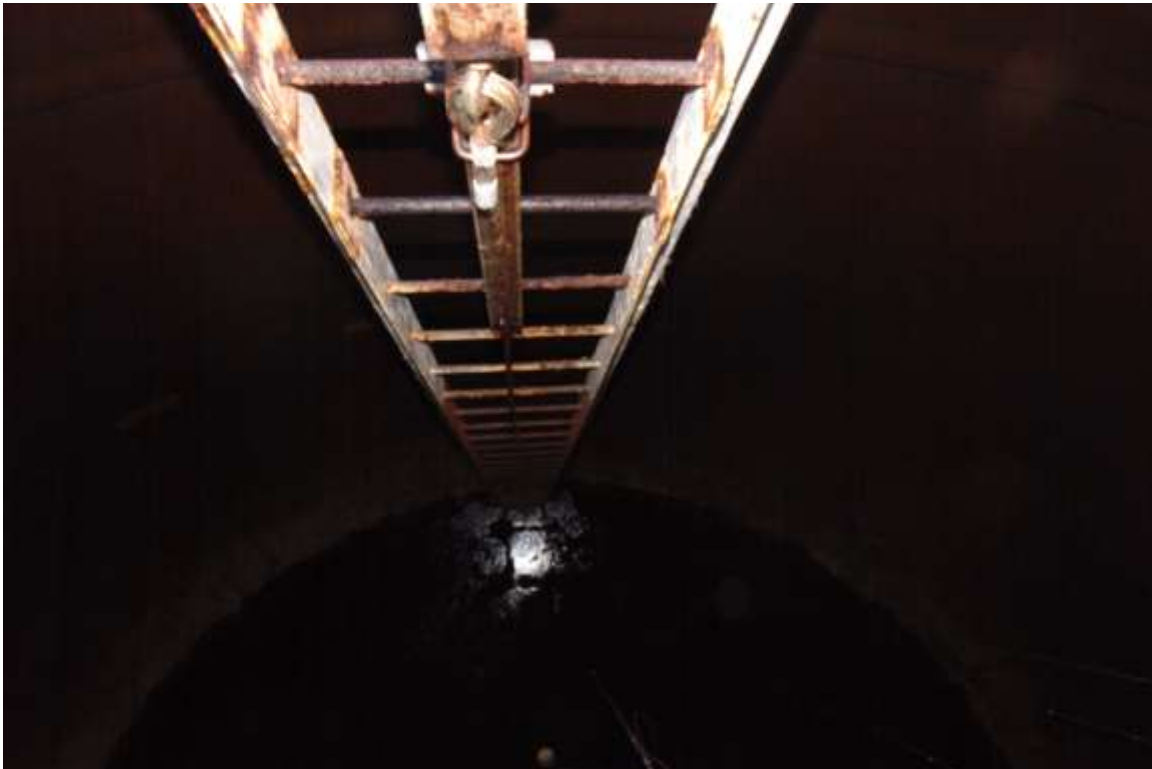
Interior access ladder in above photo appears to be in good condition. We recommend installing an **OSHA** compliant interior access ladder complete with standoffs every 10' on center and cable type ladder safety devices at the suggested secondary roof manway.

We further recommend installing compliant interior bowl ladders complete with standoffs every 10' on center and cable type ladder safety devices at the suggested primary and secondary shell manways.

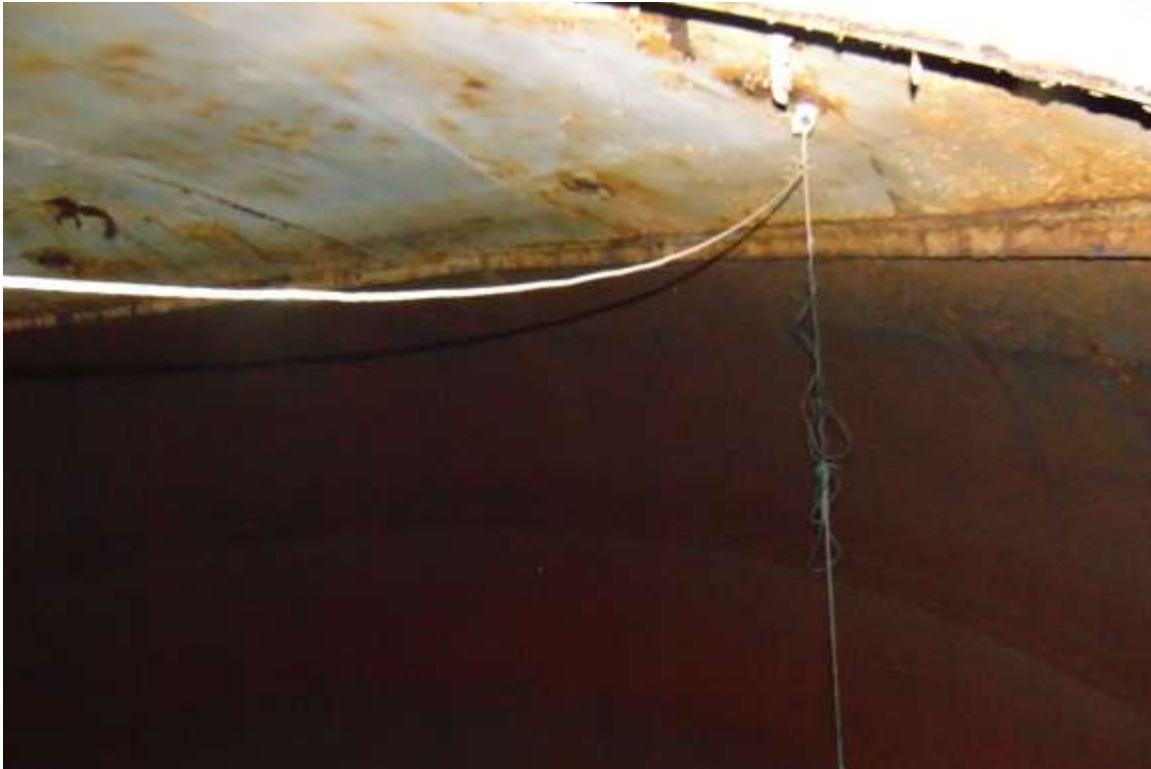
Photo shows the condition of the interior roof. Notice the rust forming at the roof seams. We recommend seam sealing using Sikaflex® 1a on all interior roof seams to prevent failure of a new interior liner. This work is to be performed in conjunction with application of new interior liner.

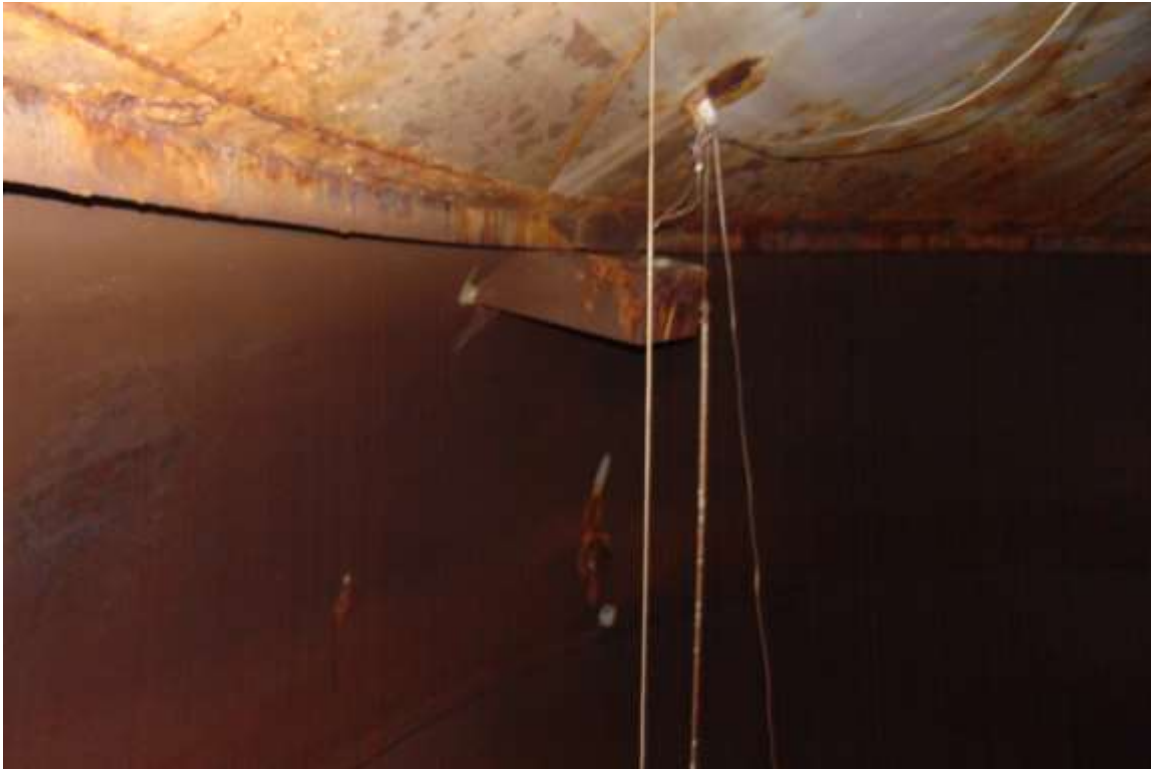
Photo shows the condition of the interior roof-to-shell connection. Notice the rust forming at the connection. We recommend seam sealing using Sikaflex® 1a around the entire circumference of this connection to prevent failure of the interior liner. This work is to be performed in conjunction with application of new interior liner.

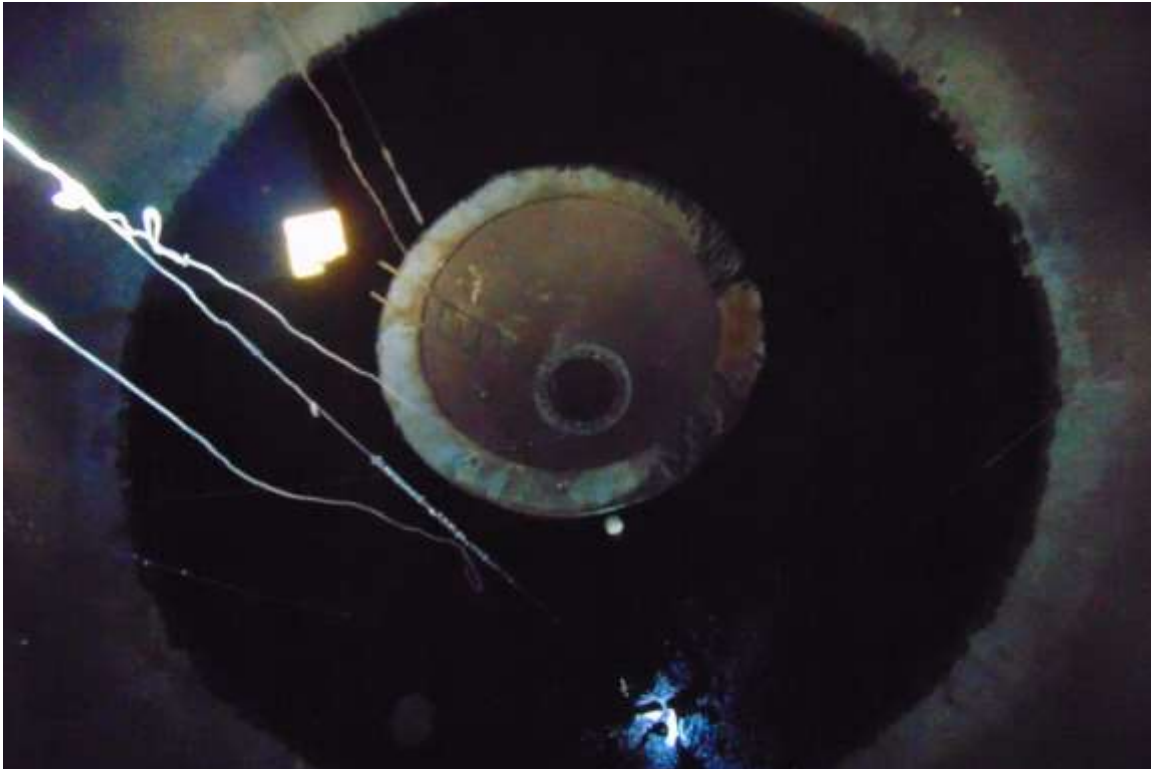
Photo shows sediment and debris in the tank. Silt ingested into the sprinkler system can clog the sprinkler heads, rendering the system deficient. We recommend that cleaning be performed in order to prevent damage to the sprinkler system.

This work should be performed on an emergency basis.

We further recommend installing a passive cathodic protection system.

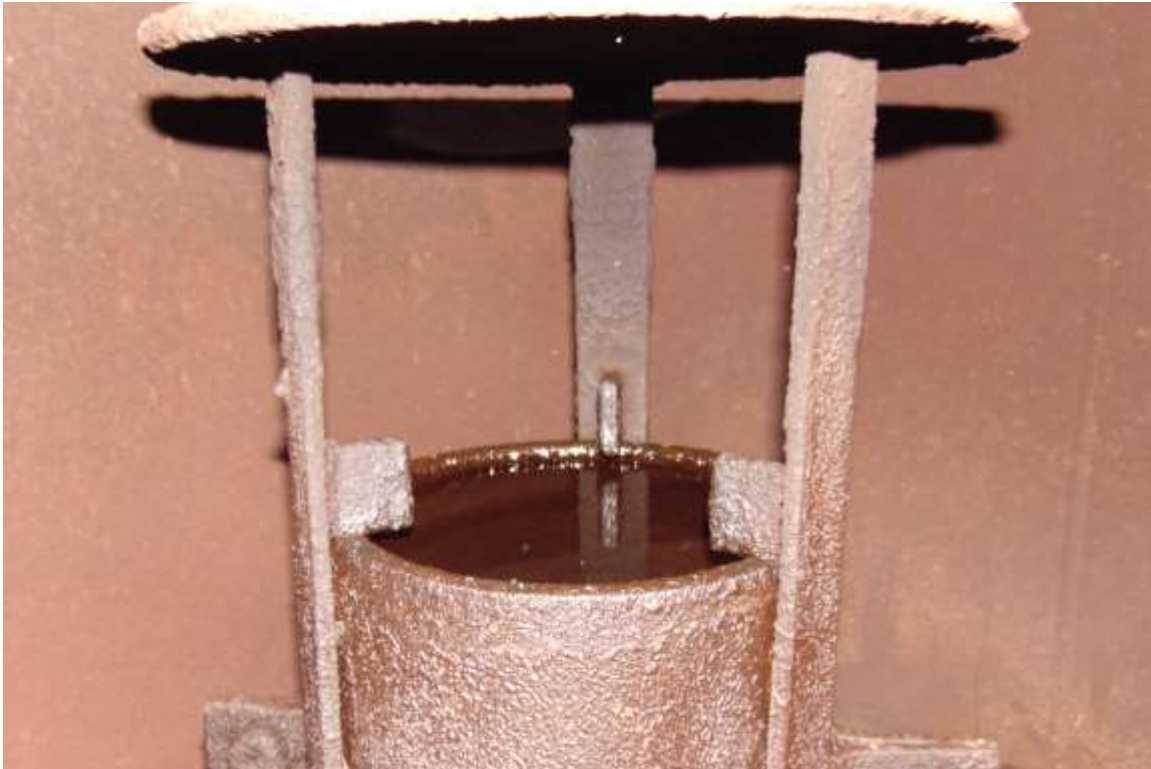
Photo shows a suction pipe on the interior of the tank, which is equipped with a properly sized anti-vortex plate to prevent formation of a vortex.

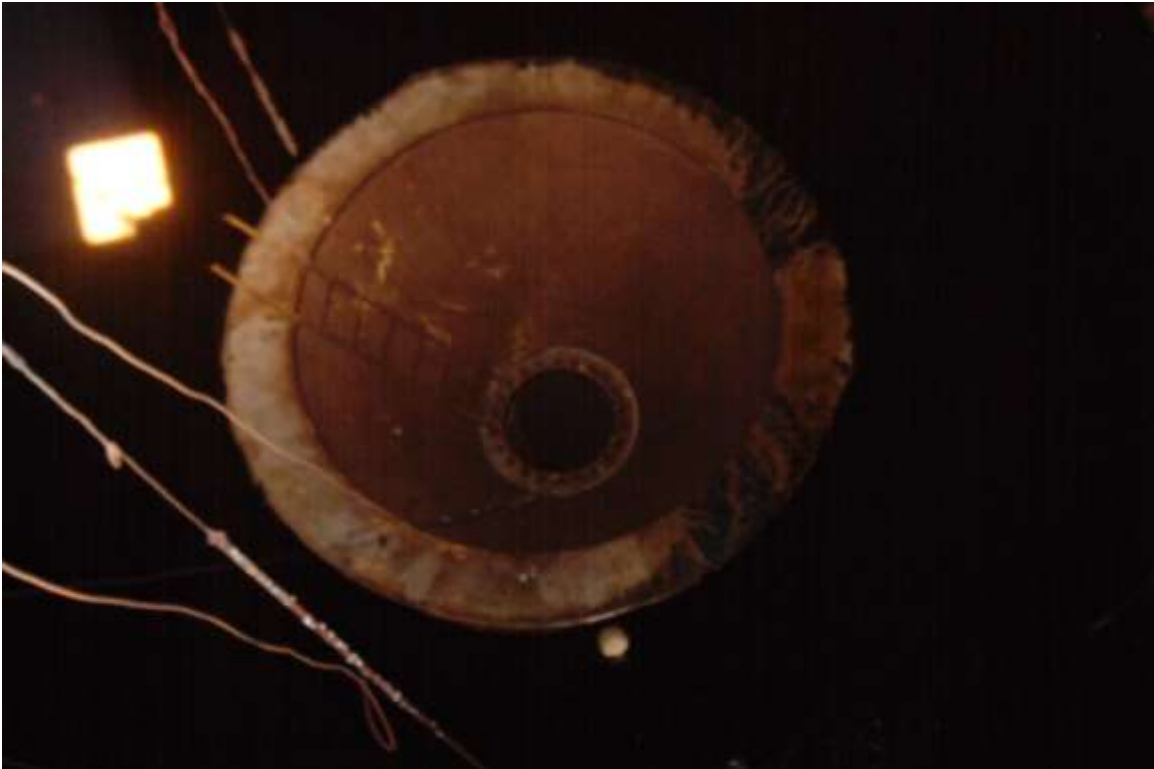
Photo shows the condition of the riser pipe opening. The riser opening is not equipped with a safety grating in accordance with **AWWA D100-11; 5.1.1: Safety Grill** and **OSHA 29 CFR 1910.23 (a)(1)**. We recommend installing an approved safety grating, designed for fall protection, over the riser opening.

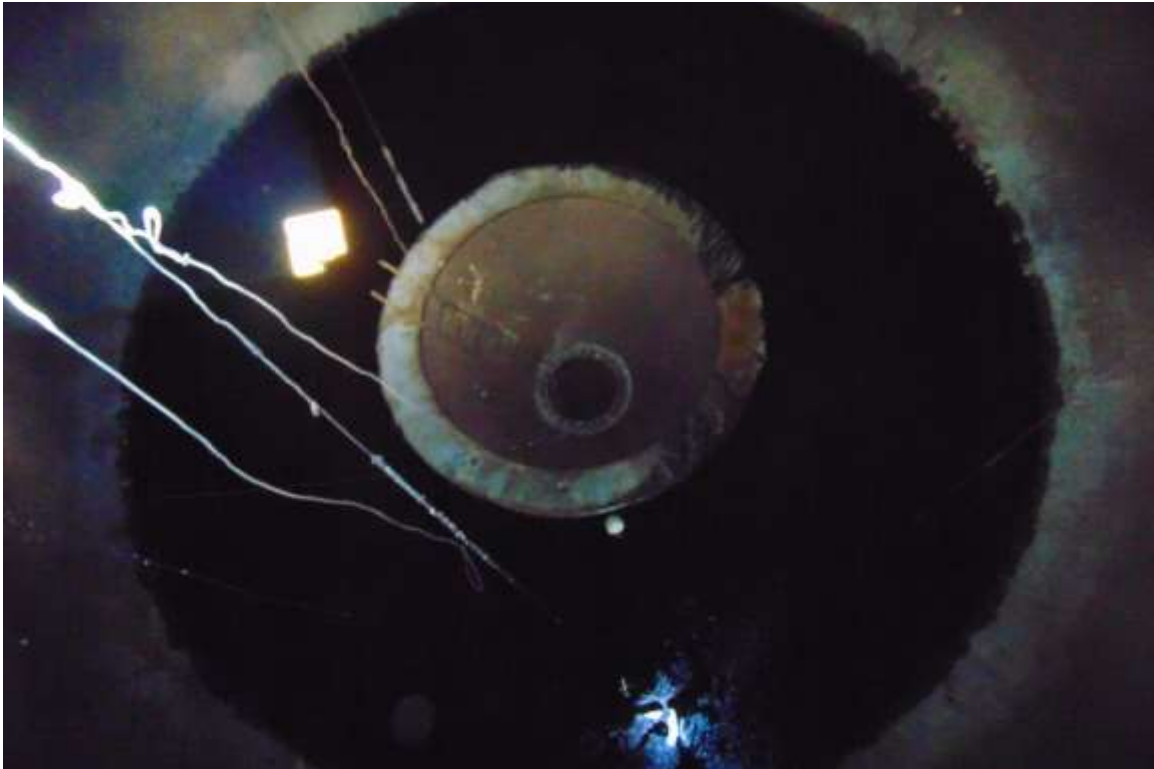
Riser ladder in above photo is not equipped with anti-skid rungs. **OSHA 29 CFR 1926.1050-1060** states, "Rungs... must be corrugated, knurled, dimpled, coated with skid-resistant material or treated to minimize slipping." We recommend installing an **OSHA** compliant riser ladder complete with standoffs every 10' on center and a cable type ladder safety device.

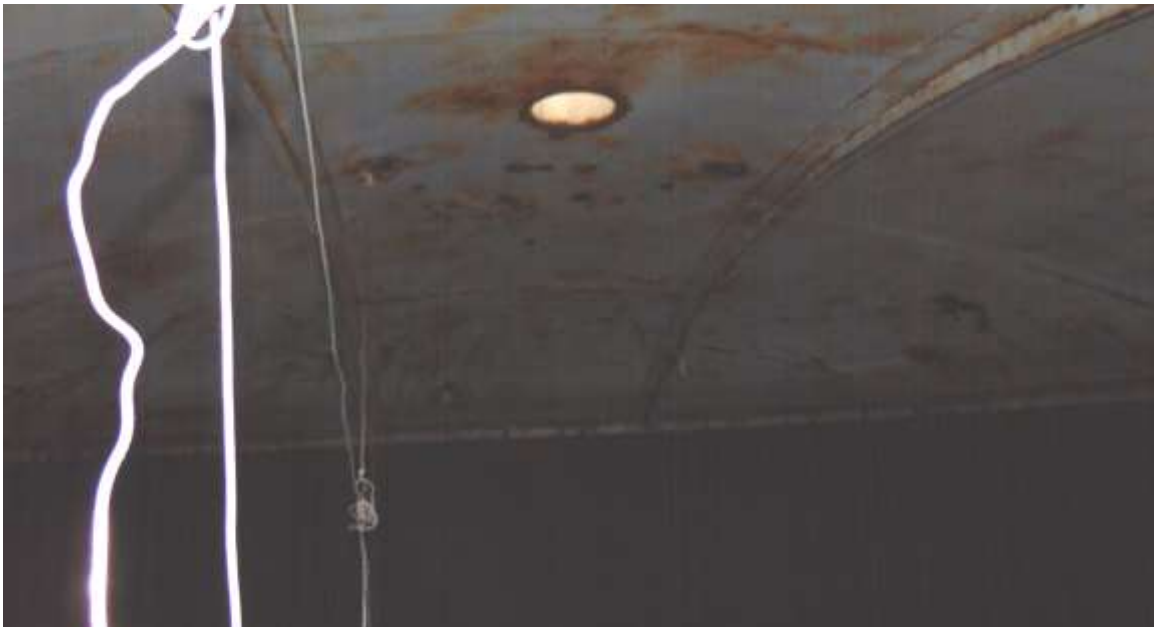
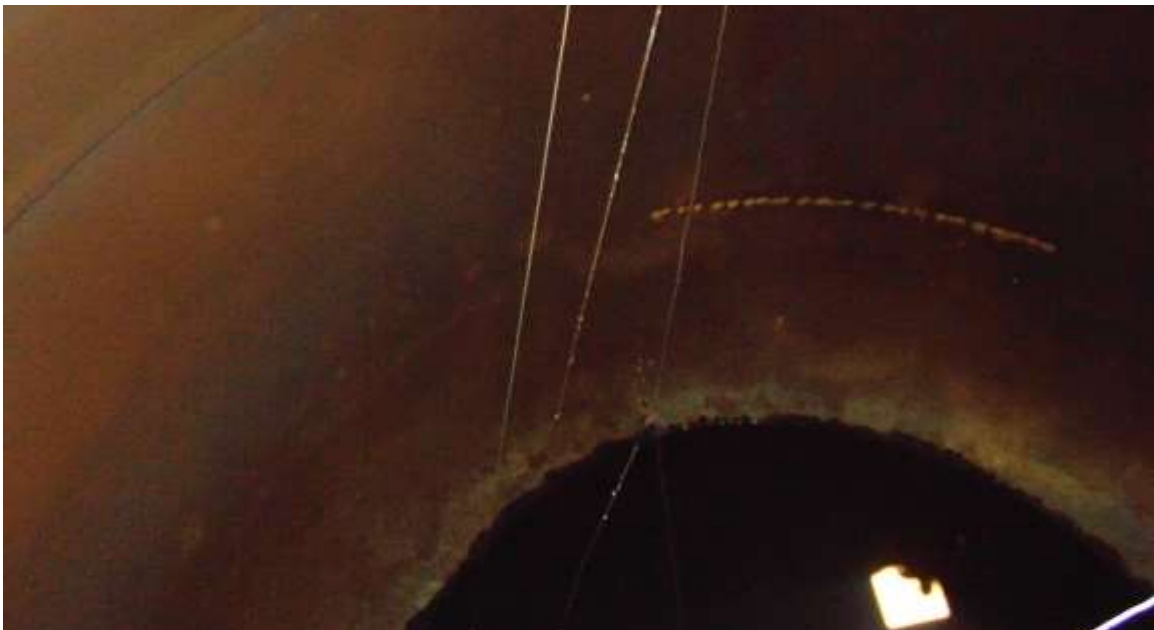
Photos show the condition of the interior liner. We recommend to sandblast, SSPC-SP10 (near white), all rusted and abraded interior areas and brush blast, SSPC-SP7, all remaining interior areas. All areas sandblasted to a #10 as well as all weld seams will receive one (1) spot coat of epoxy primer and one full coat epoxy will then be applied to the entire tank to achieve 8 to 10 mils of total dry film thickness. Total milage includes a combination of the existing and new coating.
