Report by ATC Environmental Consultant

August 31, 2018

**Re: Community Building, 735 Longmeadow Street, Longmeadow MA  
Asbestos & Lead Paint Testing**

**Longmeadow Town Hall, Longmeadow, MA  
Lead Paint Testing**

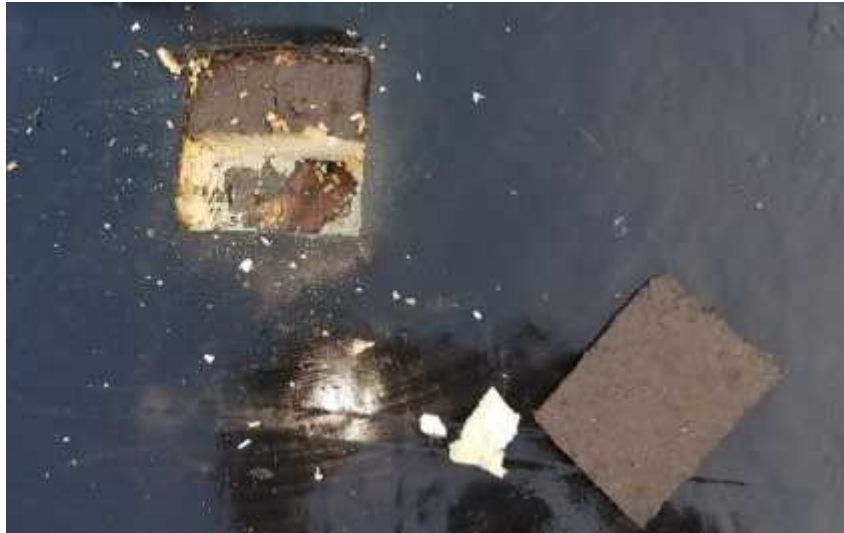
Figure 1- Community Bldg. Roof, Field

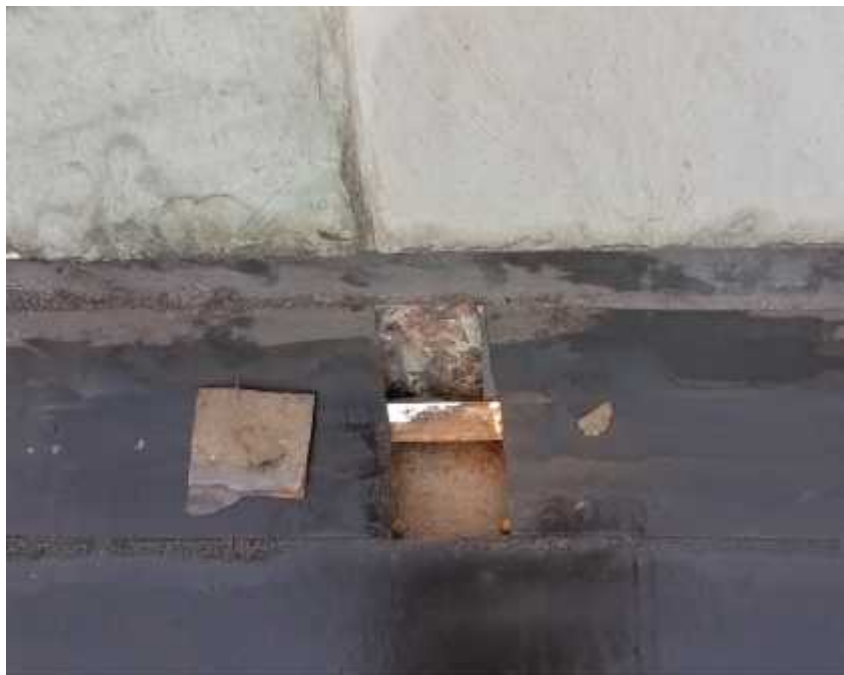
Figure 2- Community Bldg. Roof, Flashing

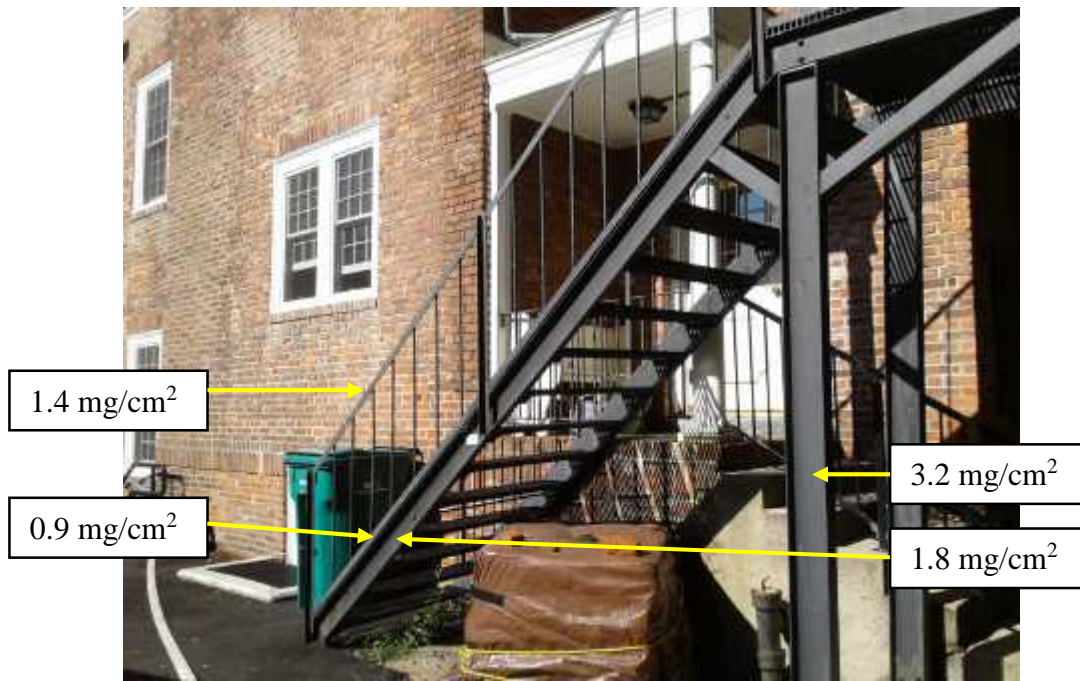
Figure 3 - Community Bldg. Fire Escape

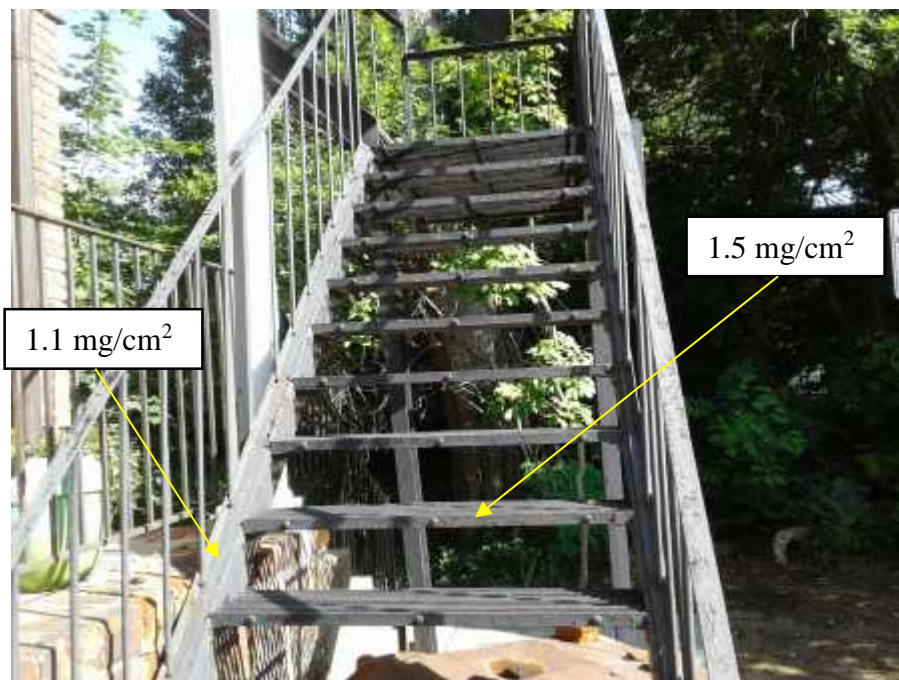
Figure 4- Community Bldg. Fire Escape

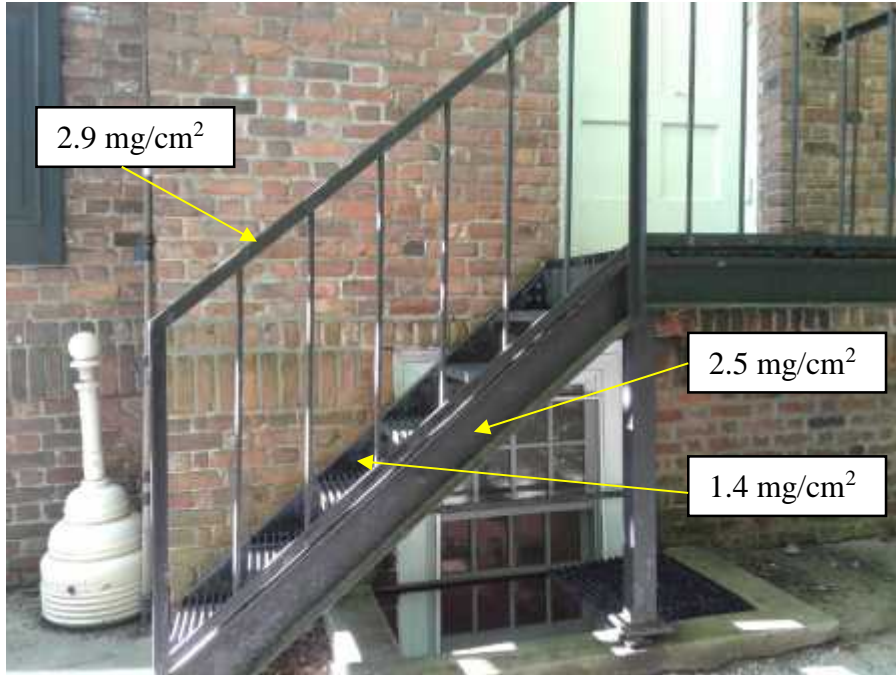
Figure 5 - Community Bldg. Small Fire Escape

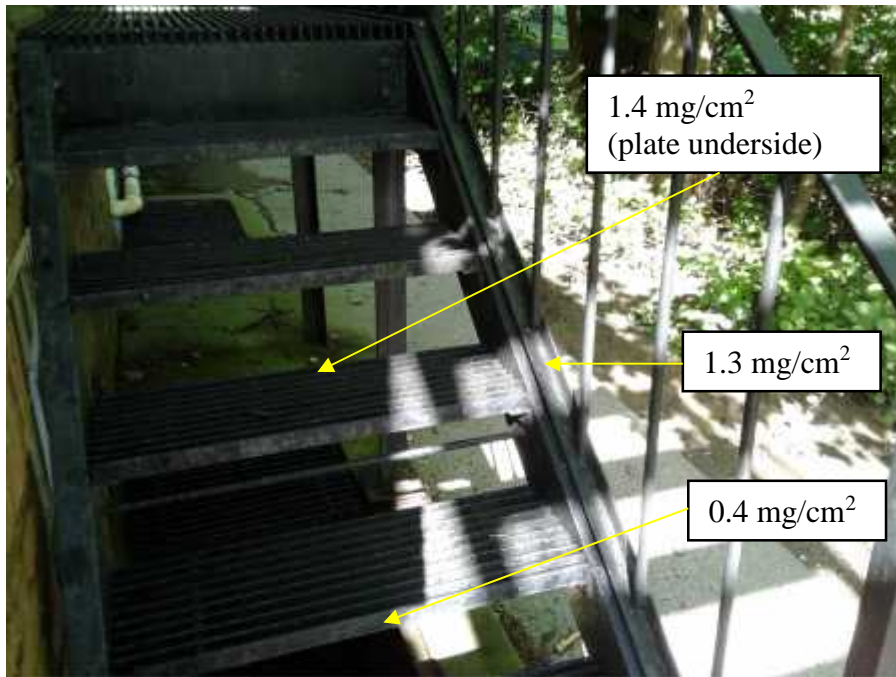
Figure 6 - Community Bldg. Small Fire Escape

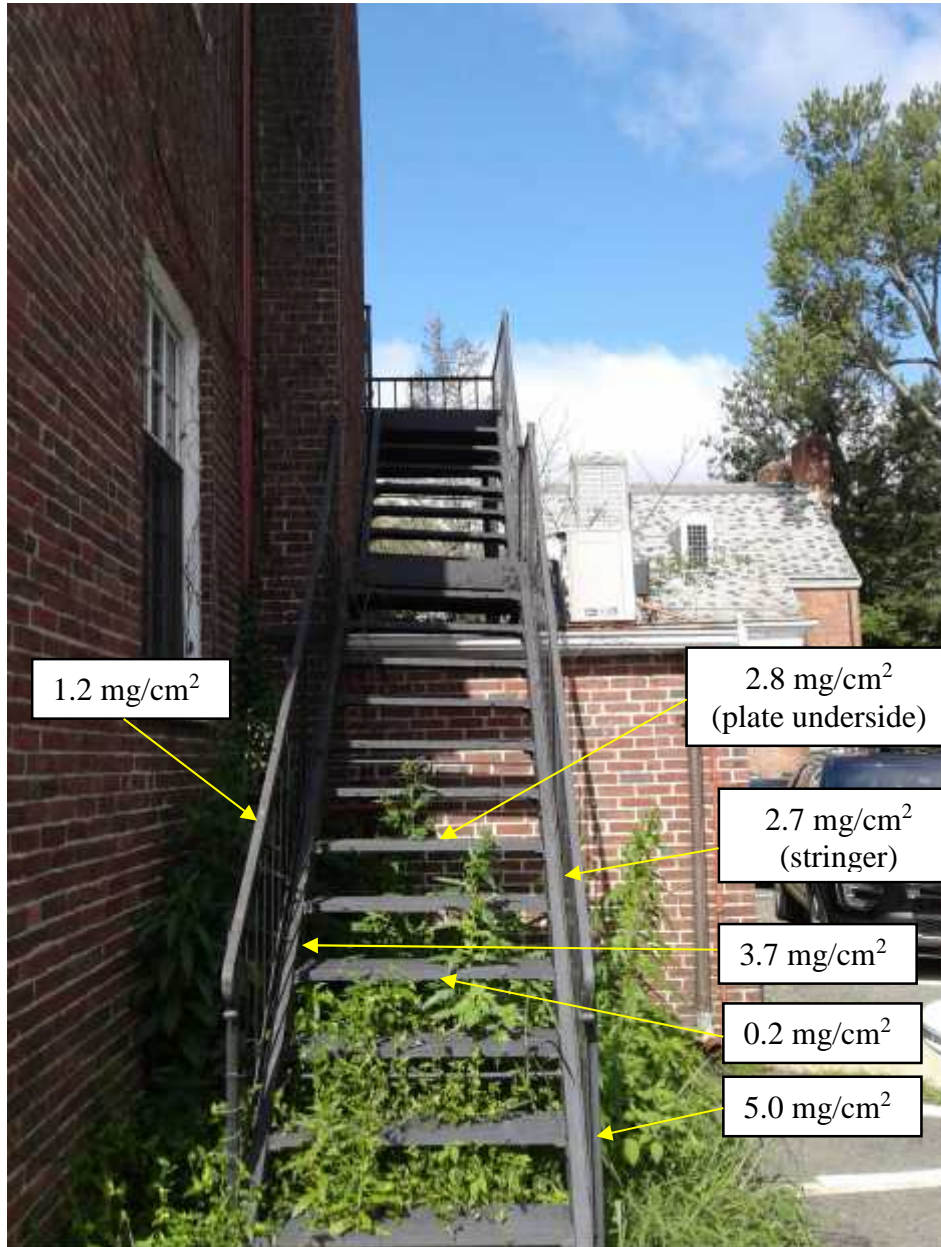
Figure 7 - Town Hall Fire Escape
