DPC Engineering, LLC  
22 Northfield Road  
Longmeadow, MA 01106  
Phone: 413-567-6310  
Email: cctv@dpcengineering.com

## LONG-SD-CB2909-CB2899

| City:<br><b>Longmeadow, MA</b> | Project name:<br><b>Longmeadow, MA</b> | Address:<br><b>Willow Brook Road</b> | Operator:<br><b>Mike</b> |
| Pipe type:<br><b>Storm Drain (SD)</b> | Pipe shape:<br><b>Circular</b> | Pipe material:<br><b>Concrete Reinforced</b> | Pipe diameter:<br><b>15.0 in.</b> |

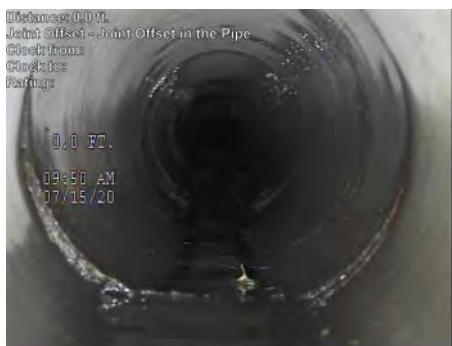
| Distance | Dir. | Length | From/To | Code | Modifier/Severity | Rating | Comments |
|---|---|---|---|---|---|---|---|
| 0.0 ft. | D | 73.4 ft. | / | Joint Offset | | | |

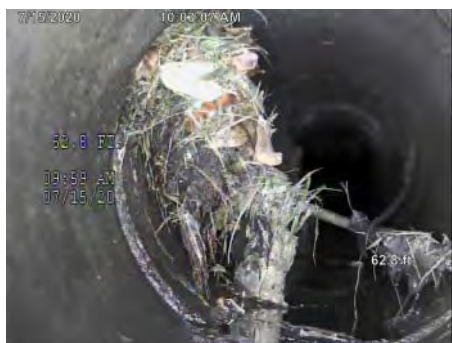
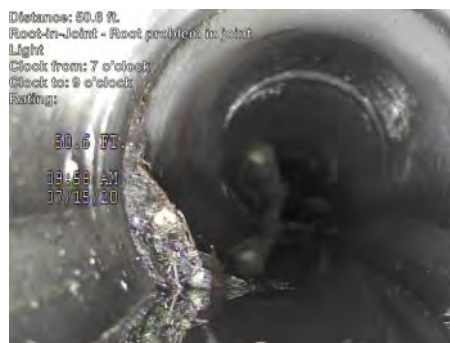
| 50.6 ft. | D | 7 / 9 | Root-in-Joint | Medium |

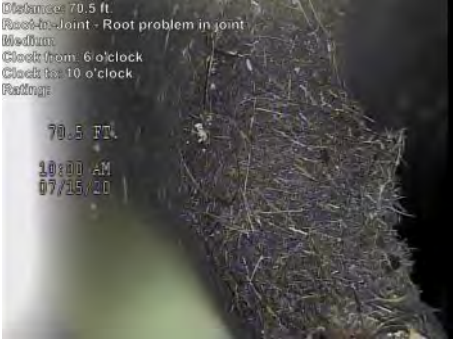
| Distance | Dir. | Length | From/To | Code | Modifier/Severity | Rating | Comments |
|---|---|---|---|---|---|---|---|
| 70.5 ft. | D | | 6 / 10 | Root-in-Joint | Medium | | |
| <div> <div> Distance: 70.5 ft.<br/> Root-in-Joint - Root problem in joint<br/> Medium<br/> Clock from: 6 o'clock<br/> Clock to: 10 o'clock<br/> Rating: </div> </div> | | | | | | | |

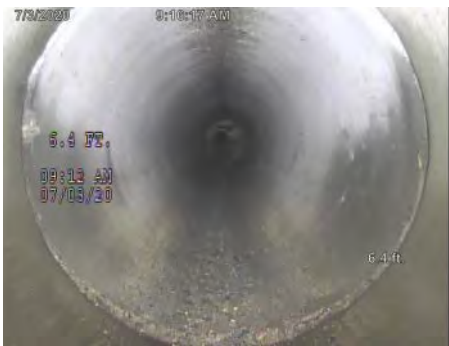
| Distance | Dir. | Length | From/To | Code | Modifier/Severity | Rating | Comments |
|---|---|---|---|---|---|---|---|
| 6.5 ft. | D | | / | Joint Offset | Small | | |

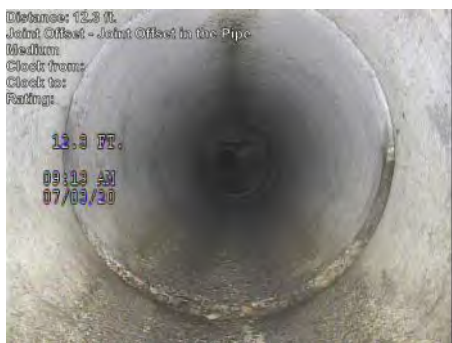
| 12.3 ft. | D | | / | Joint Offset | Medium | | |

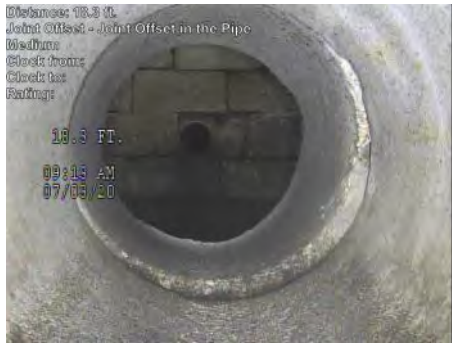
| Distance | Dir. | Length | From/To | Code | Modifier/Severity | Rating | Comments |
|---|---|---|---|---|---|---|---|
| 18.3 ft. | D | | / | Joint Offset | Medium | | |

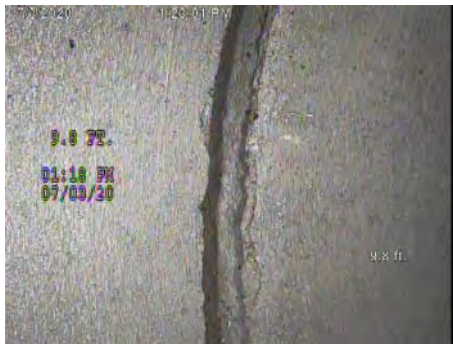
| Distance | Dir. | Length | From/To | Code | Modifier/Severity | Rating | Comments |
|---|---|---|---|---|---|---|---|
| 9.8 ft. | D | 56.2 ft. | / | Joint - Separated | Small | | |

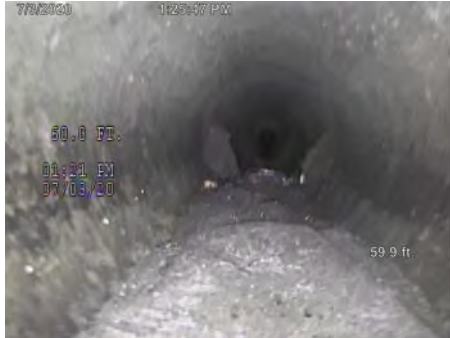
| 60.1 ft. | D | 5.9 ft. | 5 / 7 | Debris | <=20% | | |

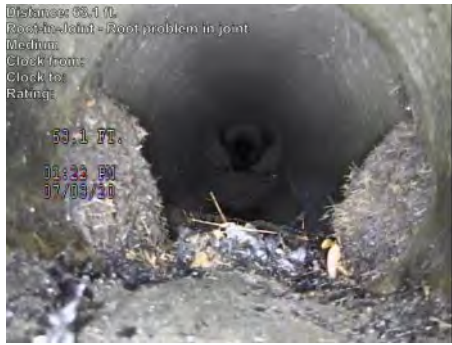
| 63.1 ft. | D | 2.9 ft. | / | Root-in-Joint | Medium | | |

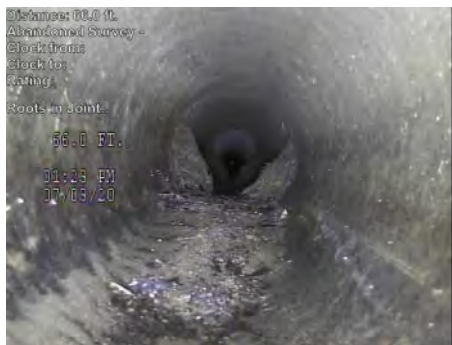
| 66.0 ft. | D | | / | Abandoned Survey | | | |

**Cannot pass  
roots/debris in joint**

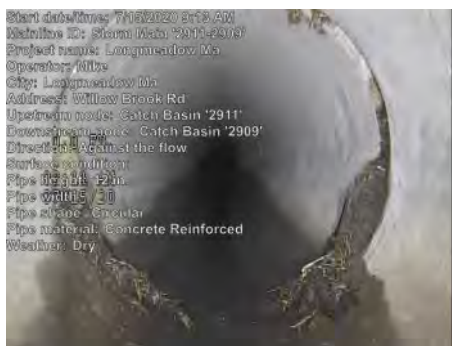
| Distance | Dir. | Length | From/To | Code | Modifier/Severity | Rating | Comments |
|---|---|---|---|---|---|---|---|
| 0.2 ft. | U | | 3 / 9 | Root-in-Joint | Light | | |

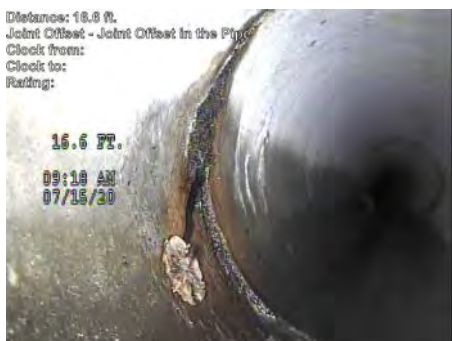
16.6 ft. U 123.8 ft. / Joint Offset

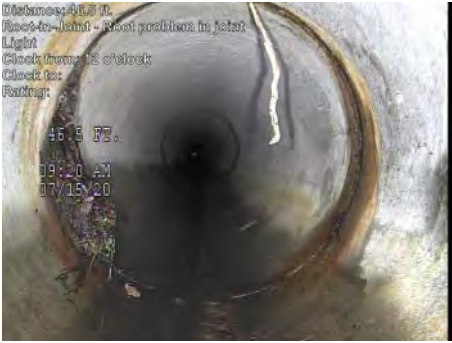
| Distance | Dir. | Length | From/To | Code | Modifier/Severity | Rating | Comments |
|---|---|---|---|---|---|---|---|
| 46.5 ft. | U | | 12 / | Root-in-Joint | Light | | |
| <div> <p>Distance: 46.5 ft.<br/> Root-in-Joint - Root problem in joint<br/> Light<br/> Clock from: 12 o'clock<br/> Clock to:<br/> Rating:</p> </div> | | | | | | | |

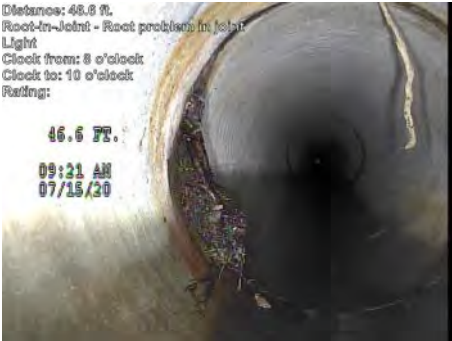
| Distance | Dir. | Length | From/To | Code | Modifier/Severity | Rating | Comments |
|---|---|---|---|---|---|---|---|
| 46.6 ft. | U | | 8 / 10 | Root-in-Joint | Light | | |
| <div> <p>Distance: 46.6 ft.<br/> Root-in-Joint - Root problem in joint<br/> Light<br/> Clock from: 8 o'clock<br/> Clock to: 10 o'clock<br/> Rating:</p> </div> | | | | | | | |

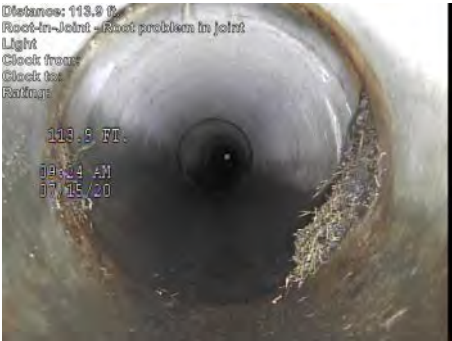
| Distance | Dir. | Length | From/To | Code | Modifier/Severity | Rating | Comments |
|---|---|---|---|---|---|---|---|
| 113.9 ft. | U | 23.5 ft. | / | Root-in-Joint | Light | | |
| <div> <p>Distance: 113.9 ft.<br/> Root-in-Joint - Root problem in joint<br/> Light<br/> Clock from:<br/> Clock to:<br/> Rating:</p> </div> | | | | | | | |

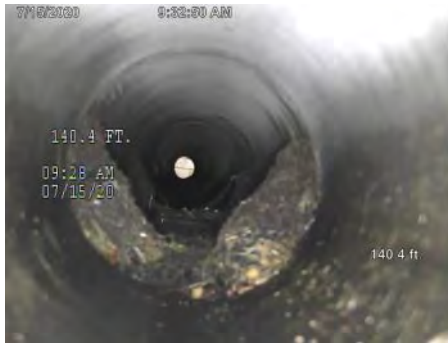
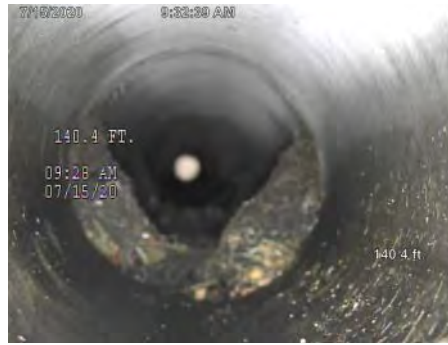
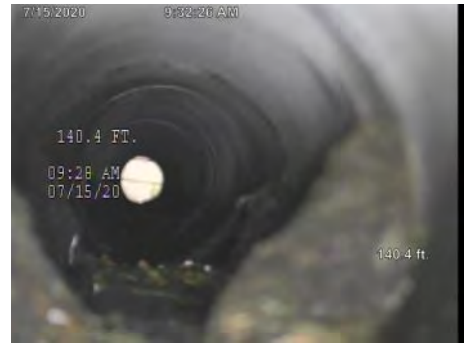
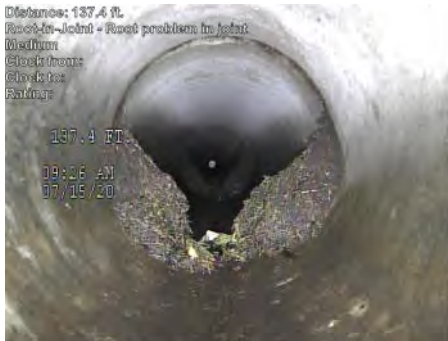
| 137.4 ft. | U | 3.0 ft. | / | Root-in-Joint | Medium | | |

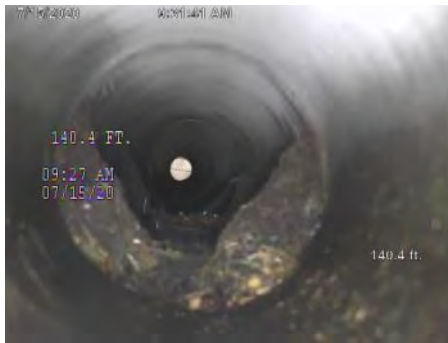
| 140.4 ft. | U | | / | Abandoned Survey | | | Could not pass roots/debris |

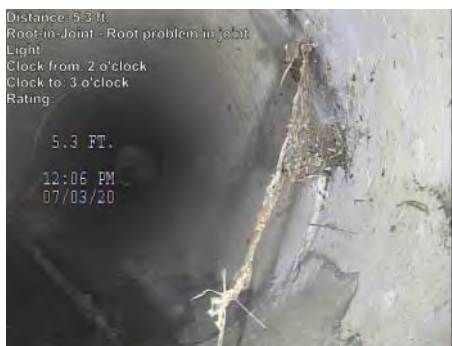
| Distance | Dir. | Length | From/To | Code | Modifier/Severity | Rating | Comments |
|---|---|---|---|---|---|---|---|
| 5.3 ft. | U | 2 / 3 | Root-in-Joint | | Light | | |
