788 Sheridan Street, Chicopee, MA 01020 Phone: (413) 331-4490 Fax: (413) 331-4494

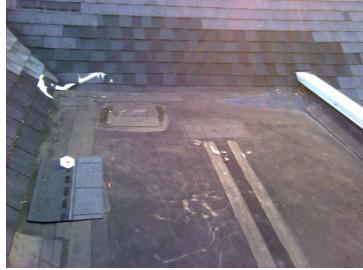
Rear Entry No Moisture - Debris Left On Roof

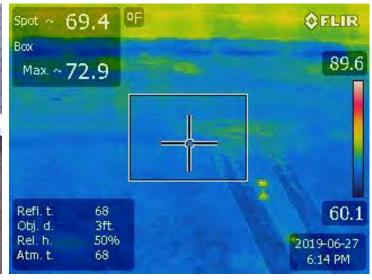
Rear Entry IR Image No Moisture

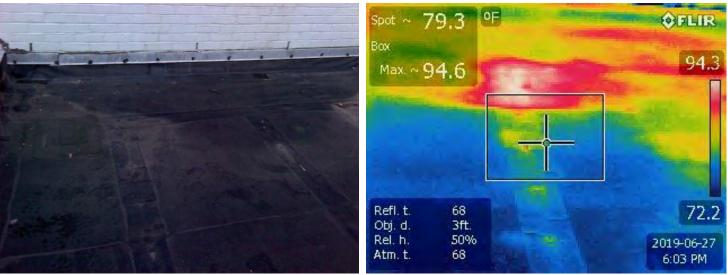
Entry Roof Control Photo Moisture at Wall

Entry Roof Moisture at Wall 2'x2' Approx.

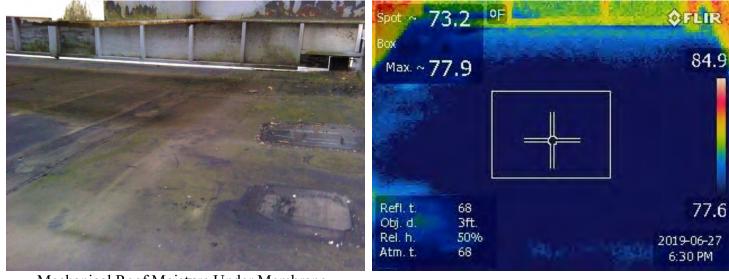
Mechanical Roof Moisture Under Membrane

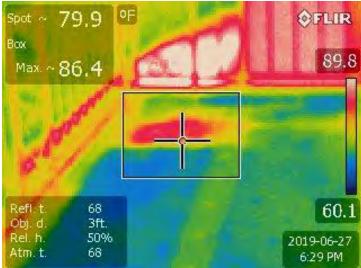
Mechanical Room IR Image At Corner Moisture Noted

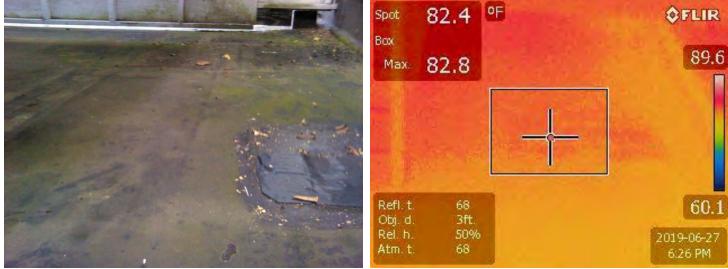
Mechanical Room IR Image Moisture Beneath Membrane Noted on Roof Plan Verified w Test Cut

Mechanical Room IR Image Moisture Noted

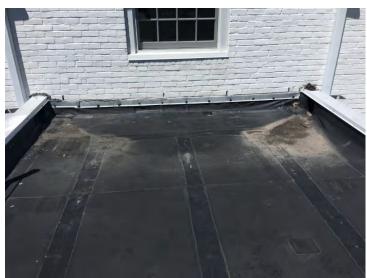
Entry Roof Counterflashing & Cricket Overall (Small Amount of Moisture 2'x2' at Cricket)

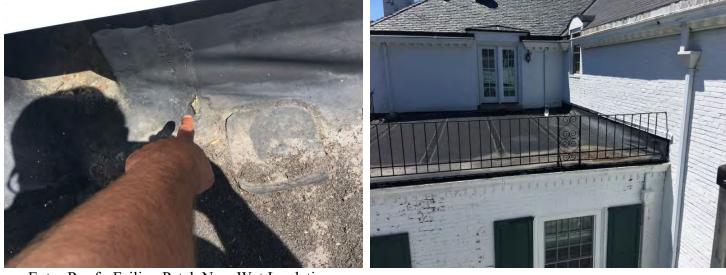
Entry Roof - Failing Patch Near Wet Insulation

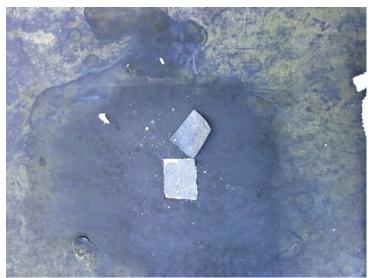
Mechanical Roof - Supreme Test Cut - Surface Moisture under membrane - Insulation = DRY

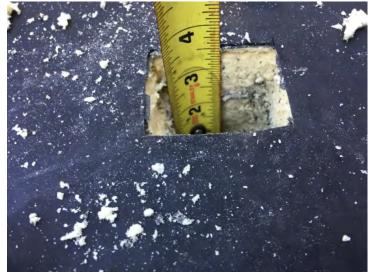
Test Cut Verified Dry Insulation from IR Scan

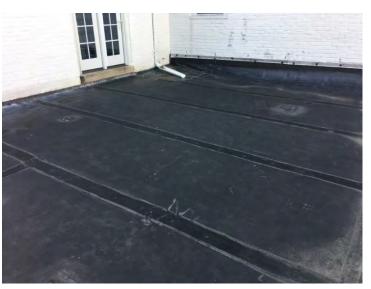
Patio Roof Entry & Corner (DS from Slope Roof) Along Wall & Corner, a small amount of moisture was noted during IR Scan

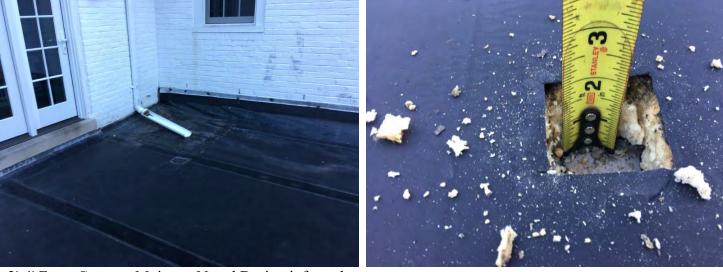
3'-4' From Corner - Moisture Noted During infra red scan (test cut was Dry Insulation)

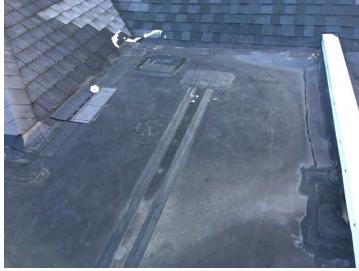
Rear Entry High Point Test Cut By Others - Shingle Tie In - Shingle Debris on Roof

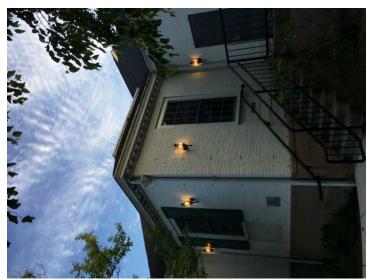
Rear Entry Ground Level View - No Moisture Detected during IR Scan
