ETOWAH ENVIRONMENTAL SERVICES

March 29, 2021

RE: Report of a Pre-Demolition Asbestos Inspection Old Gymnasium and Fieldhouse Building at Cartersville High School Cartersville, Georgia 30120 Etowah Project No. 2021-13A

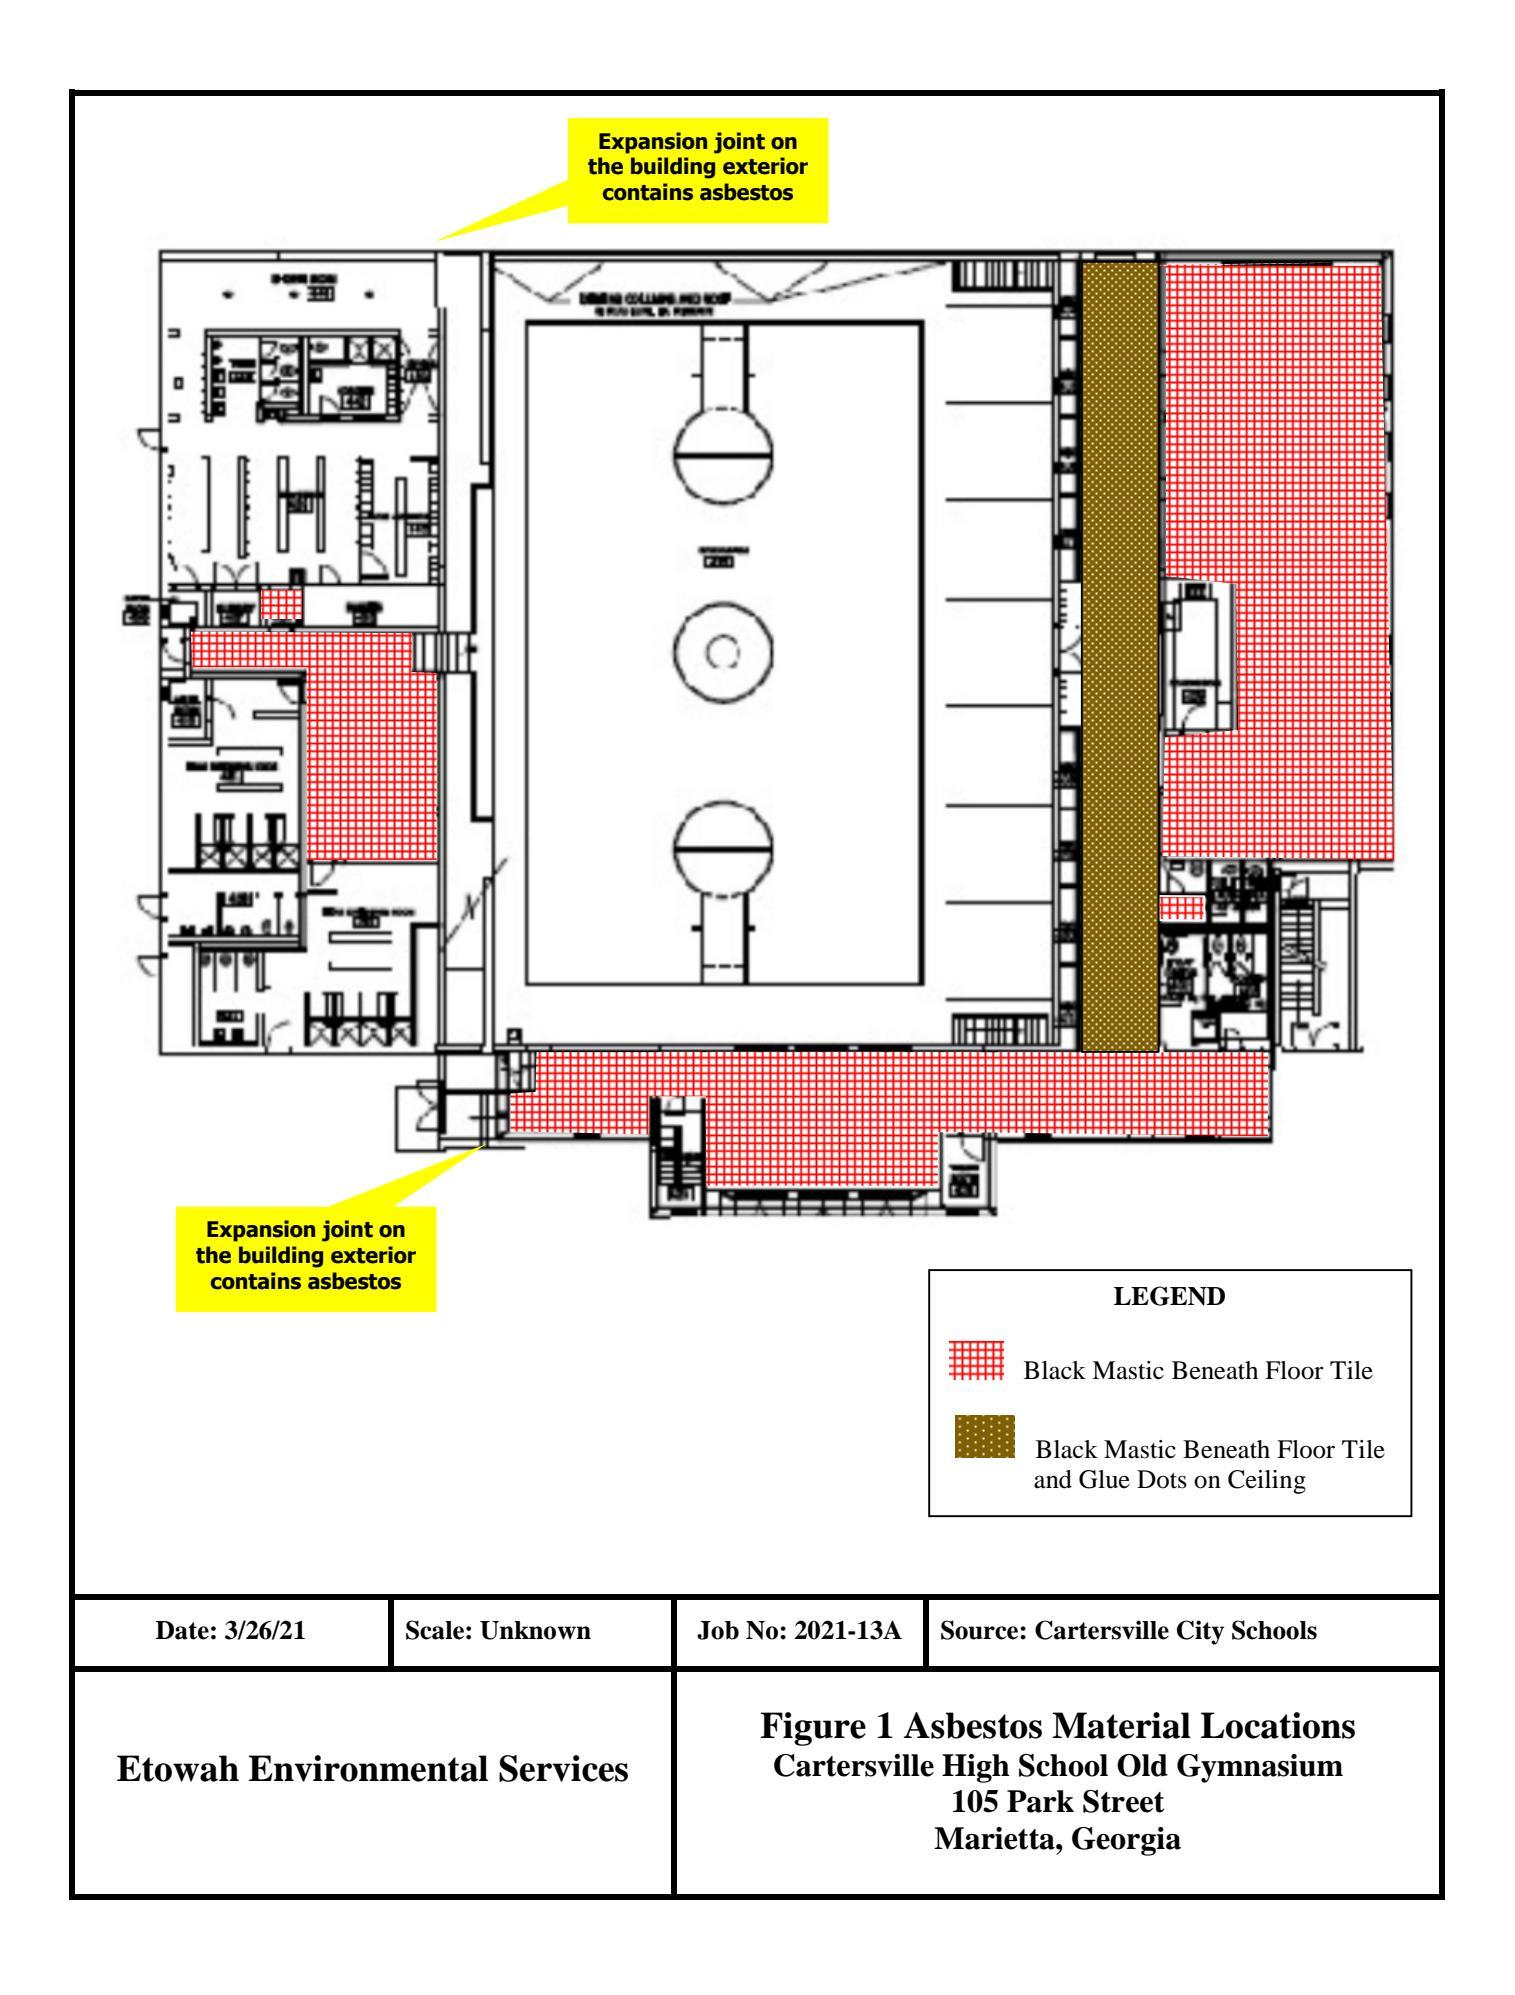
FIGURES

Representative photographs of the detected asbestos materials are provided in the attachments to this report. A figure showing the locations of the asbestos-containing materials is also provided in the attachments.

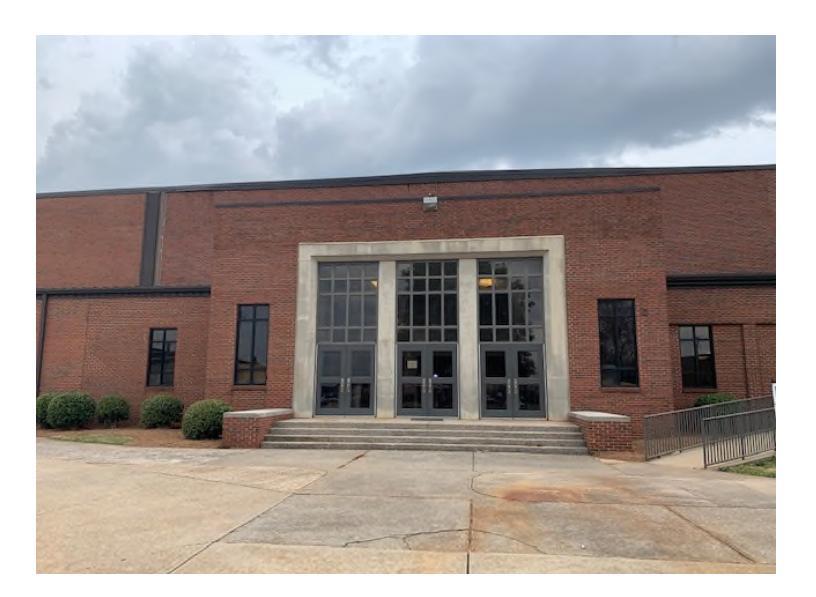
1. Shows a view of Old Gymnasium Building.

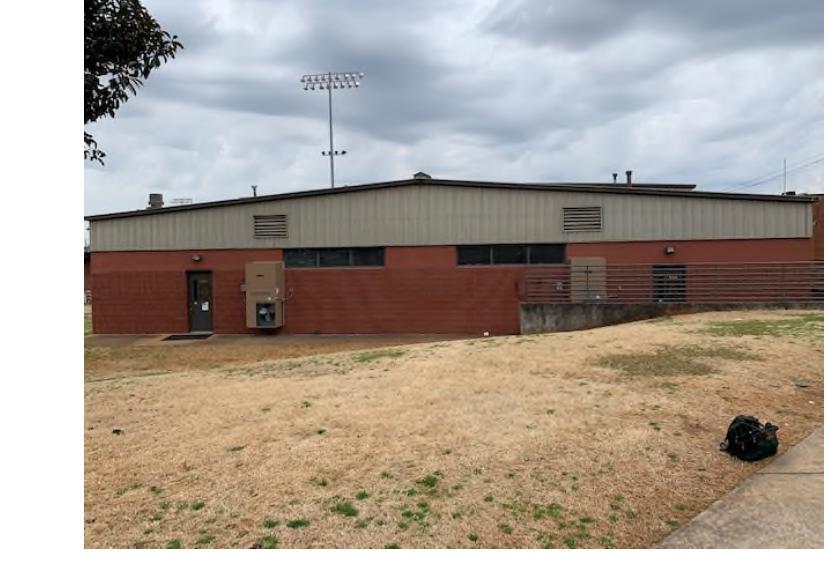
2. Shows the Old Fieldhouse Building. No asbestos was detected in the samples from

this building.

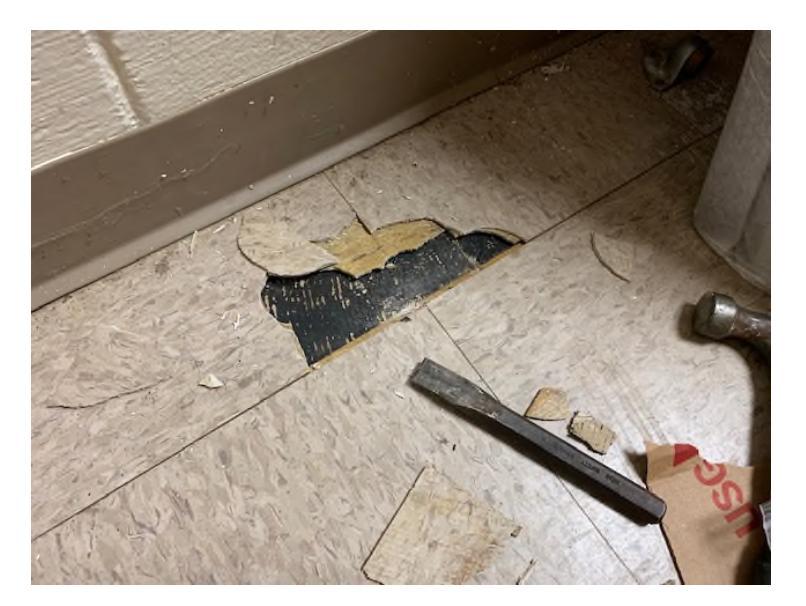
• The black mastic used beneath non-asbestos containing vinyl floor tiles the Old Gymnasium Building contained from less than 1% to 3% chrysotile asbestos. The tile

and mastic were found in the entrance lobby of the gymnasium, in the corridors and offices of the locker room area, and in the corridors, classrooms and offices in the eastern portion of the building. It is estimated that 3,950 square feet of the mastic is used in the Old Gymnasium Building.

3. Shows a view of asbestoscontaining floor tile mastic beneath two layers of tile in the locker room corridor.

Etowah recommends that a licensed asbestos contractor be retained to remove the RACMs from the Old Gym Building prior to demolition.

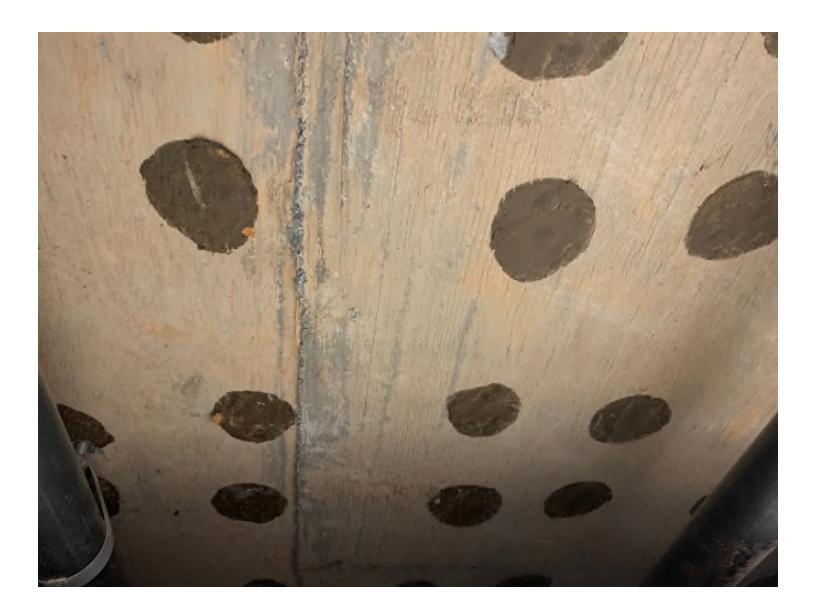
- Two percent (2%) chrysotile asbestos was detected in brown "glue dots" found above the ceiling in the corridor outside of the eastern portion of the gym. The glue dots are used on the concrete ceiling and formerly held spline ceiling tiles to the ceiling. It is estimated that the glue dots are used on approximately 675 square feet of the concrete ceiling deck above the east hallway of the Old Gym Building.
- Two percent (2%) chrysotile asbestos was detected in a grayish white caulk material used to fill expansion joints between the original gymnasium building and the western addition to the gym building. It is estimated that the asbestos containing calk is used on approximately 150 linear feet of the expansion joint on the building exterior.

4. Shows asbestos-containing brown "glue dots" on the concrete ceiling of the east hallway in the Old Gym.

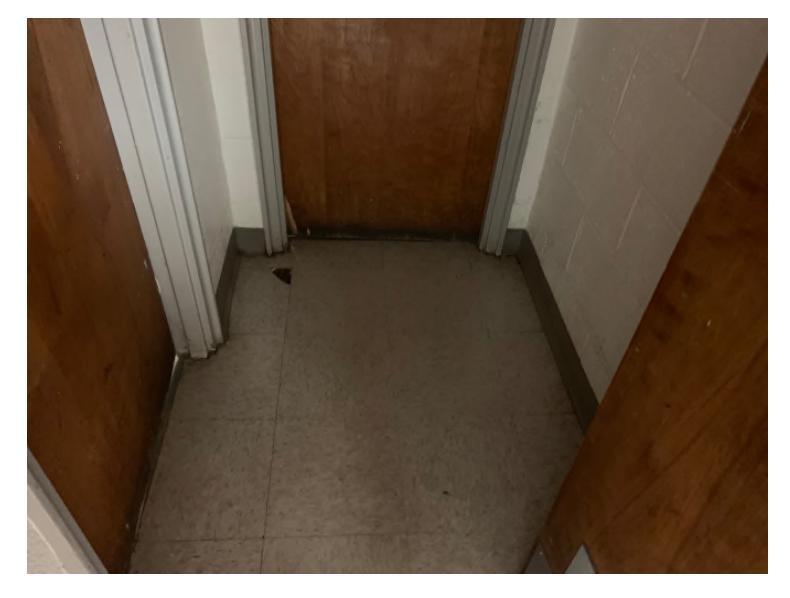
5. Shows asbestos-containing floor tile mastic beneath non-asbestos floor tile in the teacher's restrooms in the east hallway.

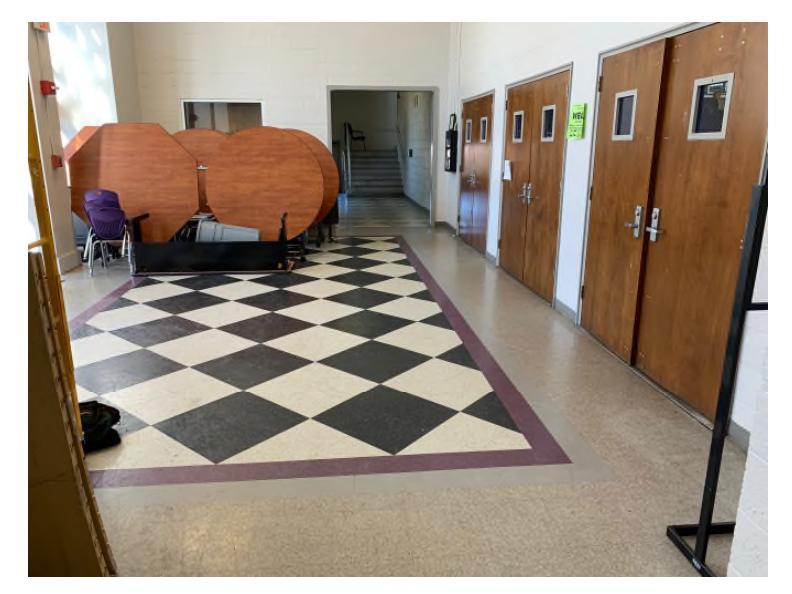
6. Shows the lobby area of the gym with non-asbestos floor tile over asbestos-containing black mastic.

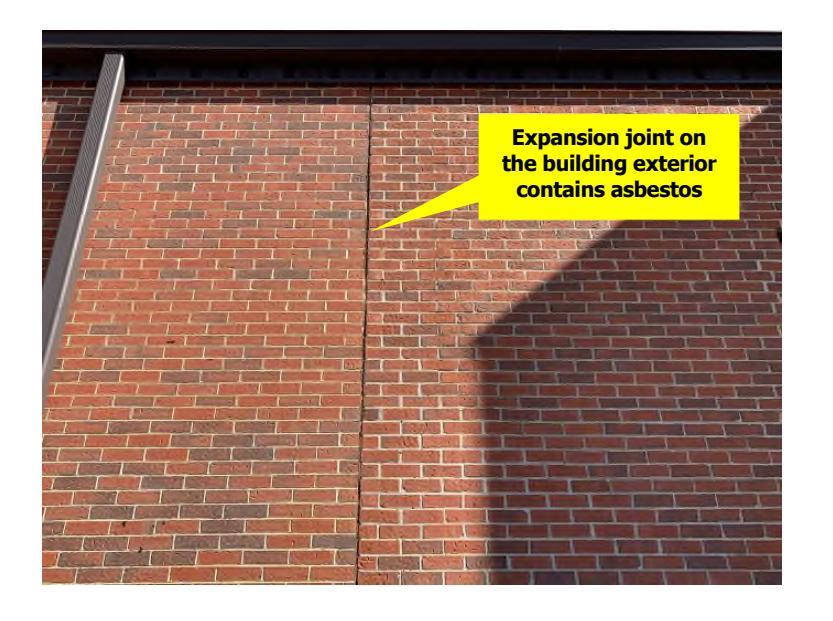
7. Shows an expansion joint between the original part of the Old gym and a section added in the 1970s. The caulk in the expansion joint contains asbestos.

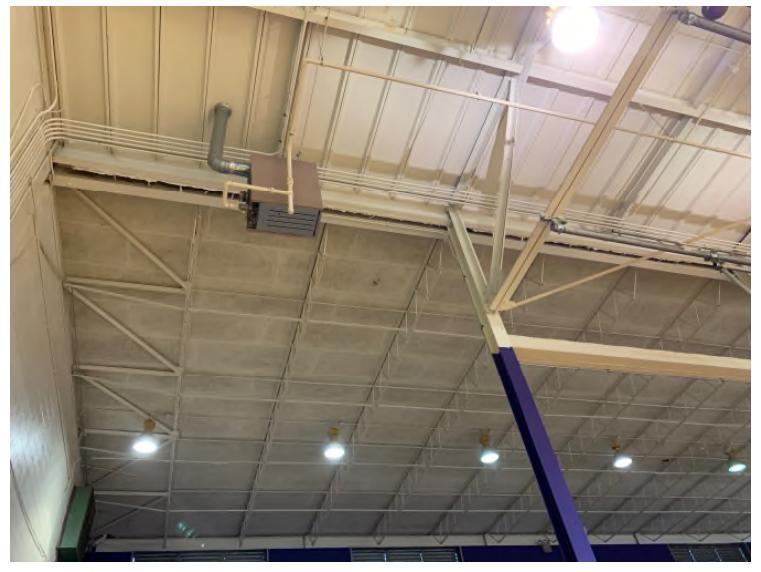
8. View of the roof detected and heaters in the old gym. No asbestos detected in those materials.

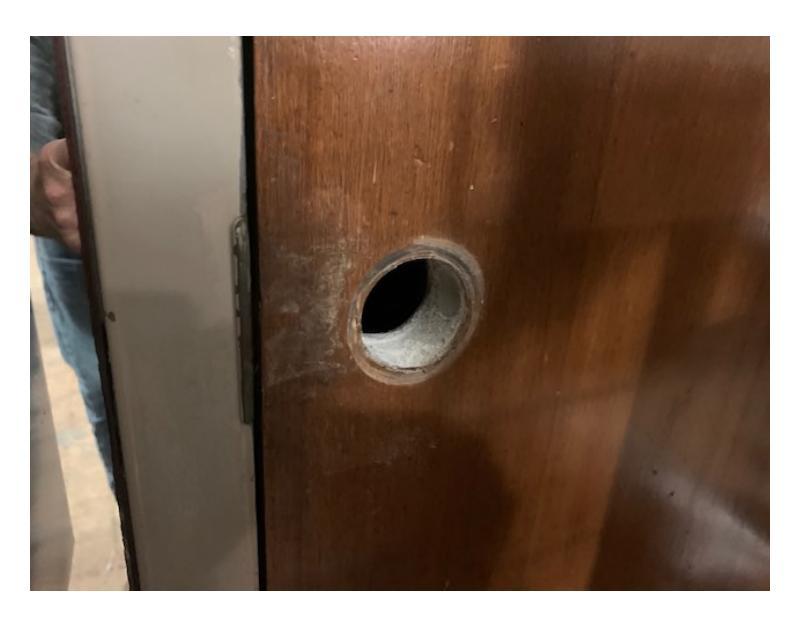
9. Shows non-asbestos containing insulation in a fire door in the old fieldhouse building.
